CONSERVATION BULLETIN SERIES

Water Management

FOR THE CONSERVATION OF HISTORIC
BUILDINGS IN SASKATCHEWAN

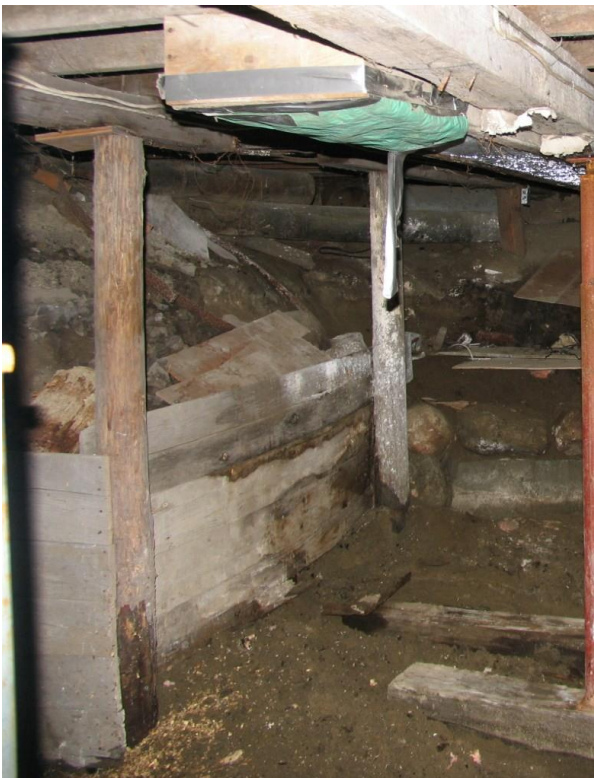
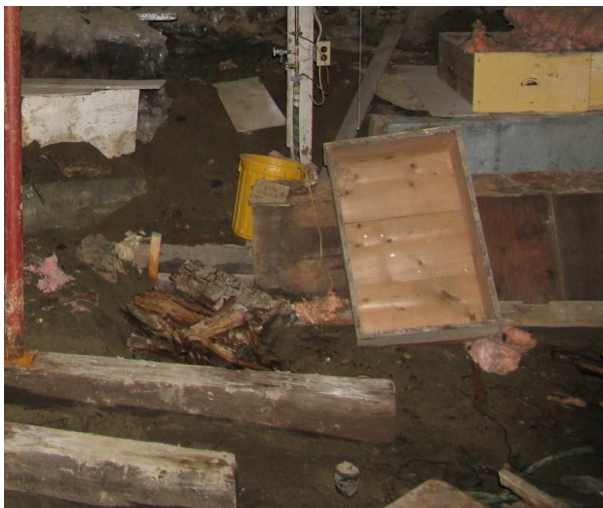
Fig. 2 — Woseley and District Museum, Woseley (M. G. Miller, 2011)

It may also be advisable to combine a sump pump with perimeter drains made of 100 mm. perforated PVC drainpipe laid in gravel inside foundation footings. These interior systems, which channel away water before it enters, may require extensive jack hammering where concrete floors are in place. Exterior or subsurface drainage systems, which run at the base of the footings, are more costly approaches because they often require removing the landscaping, excavating to expose the foundation, covering it with a waterproofing membrane and laying perimeter footing drains in a bed of gravel. Additional work may be required in basements that have retained a soil floor. In these instances, the water in the soil will not only have to be managed with internal drains and/or external pe-

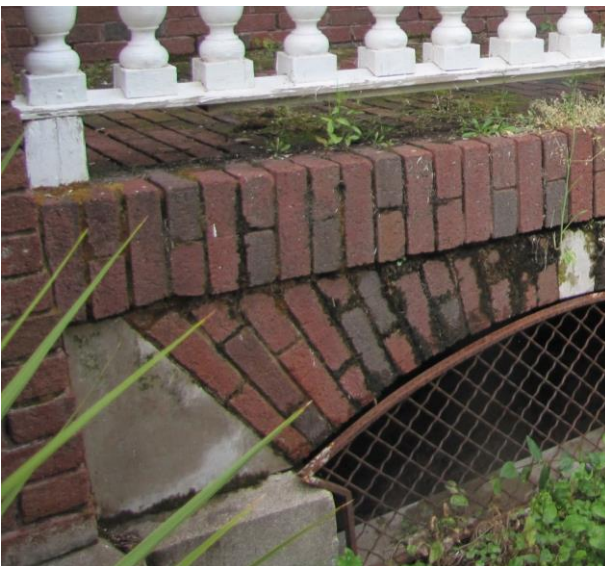
When moss takes over your exterior masonry floor, it may be a sign of inadequate drainage.

As with efflorescence, the appearance of moss, mold, mildew, lichens or algae is usually an indication that excess moisture is present. This excess moisture may result from ponding, where depressions in the masonry allow moisture to collect. Exterior decks, patios, landings and verandahs need to be so designed as to allow rain-water that is collected, to be drained away. This preferred condition does not always apply to heritage structures that may have been designed differently or may have settled over time. If the

Before attempting to correct the biological growth on the surface of the masonry, determine the source of excessive moisture, i.e. leaky downspout, standing water, etc., make any necessary repairs to the “components” of your water management system first. Then determine the type of biological growth that is present. If lichens and algae for example, the following procedure may be most effective:

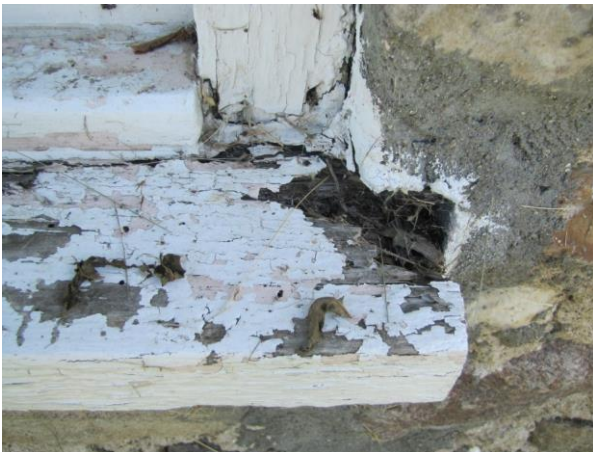
Fig. 4 — Timber sill showing effects of moisture entrapment, Stone Church, Wishart (M. G. Miller, 2011)

ous for collecting water and if there are not adequately sloped to drain, they can be a weak spot in your exterior wall (Figure 4). Unattended deterioration can allow water to migrate into the wall where further deterioration of the historic fabric can continue and go un-noticed. In this instance, the sill has reached a stage of deterioration that only replacement in kind will address ongoing deterioration to the masonry wall.

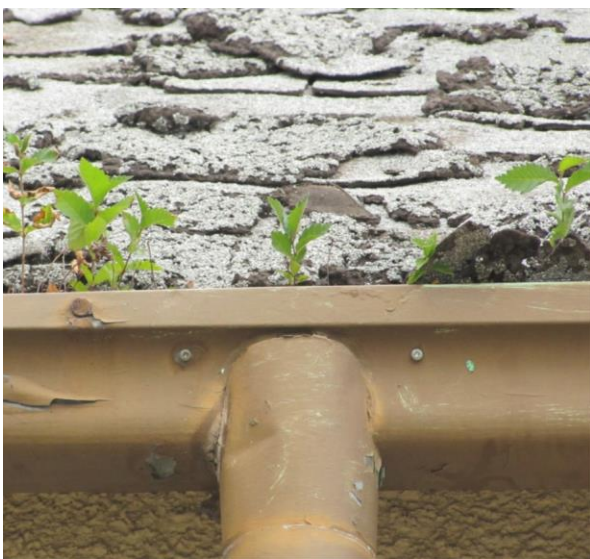
Fig. 7 — 1772 Montreal Street, Regina
(M. G. Miller, 2011)

In certain circumstances, allowing excessive water to infiltrate your heritage property may lead to the growth of plants in places that are difficult to garden (Figure 7). These locations may also impede the free flow of water from your eaves troughs (gutters) to the rain-water leaders (downspouts).

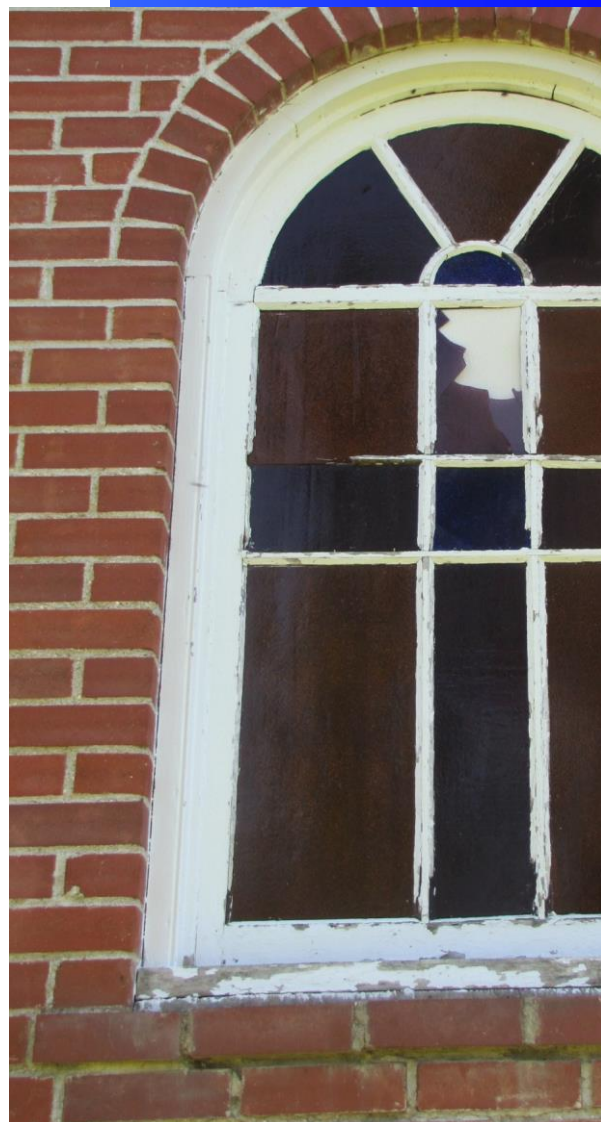
Fig. 8 — Biological growth in the mortar joints,
Ukrainian Catholic Parish of St. John Bohoslow, RM of
Big Quill
(M. G. Miller, 2011)

With regards to biological growth on masonry walls (Figure 8) see also the discussion regarding *exterior floors* on page 7 and the corresponding condition depicted in Figure 3. In a similar order of investigation, property owners should examine their water management system and identify the source of the problem before embarking upon any masonry conservation work.

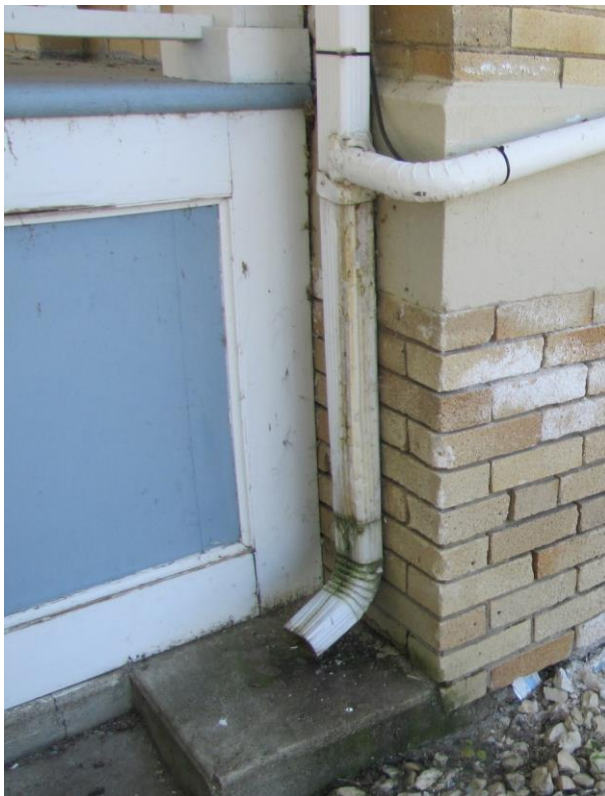
*Fig. 9 — Bishop's House, Gravelbourg
(M. G. Miller, 2011)*

In the case of the Bishop's Residence, however, brushing alone will not address the advanced state of salt migration that has resulted in the powdering of the masonry. Here, the extensively deteriorated masonry will need to be removed and replaced in kind after the water source has been addressed..

At the Bishop’s Residence for example, a rain-water leader must travel a circuitous route with many joints that may be prone to leakage. This, in combination with the disposal of the collected water immediately adjacent to the foundation is not particularly advantageous.

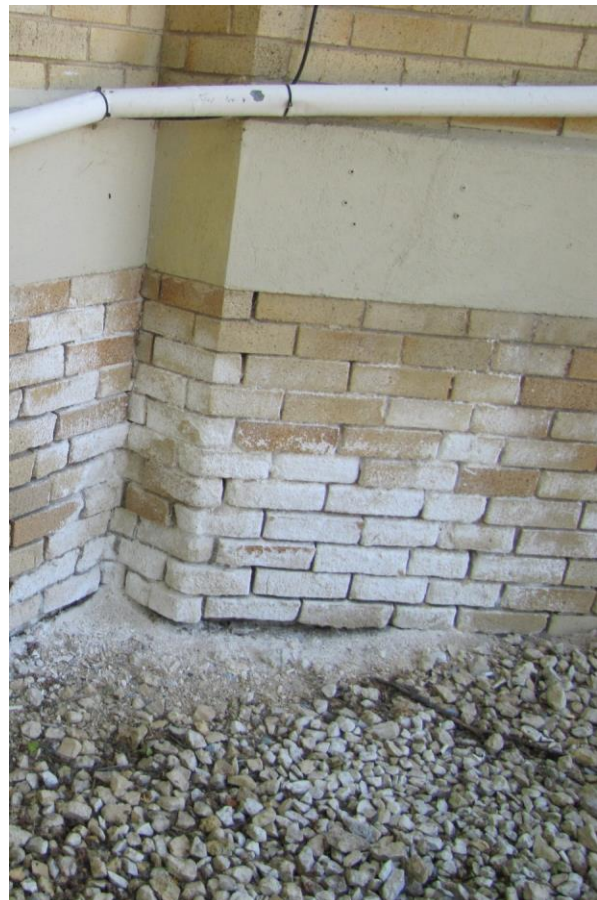
Rain-Water Leaders at Walls

Defective rain-water leaders are often the first step on the road to ruin, however, preventative measures can be very practical.

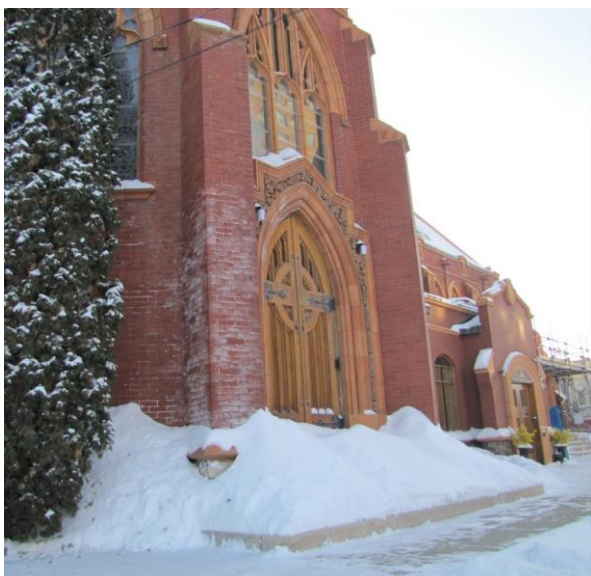
Fig. 10 — St. John’s Anglican Cathedral, Saskatoon (M. G. Miller, 2011)

In relation to St. John's Anglican Cathedral in Saskatoon, the efflorescence appearing on the exterior masonry wall and buttresses (Figure 10) is a result of water infiltrating the building envelope from the eaves troughs which had been continuously repaired over the years by adding new layers of membranes within the gutter, thus reducing the capacity

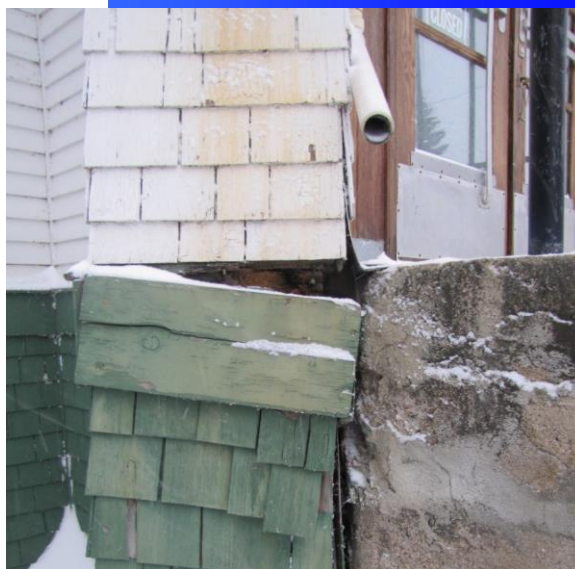
Fig. 11 — St. Walburg Museum, St. Walburg (M. G. Miller, 2011)

Much further north in St. Walburg, the location of the rain-water leader in relation to an opening-up of the projecting wall forms the conditions that are conducive to impressive

water infiltration at the Museum (Figure 11). Two immediate interventions are appropriate in these circumstances:

- Install a temporary rain-water leader to carry the water away from the building; and
- Protect the exposed structure from further water infiltration by tarping the area until more permanent conservation works can be undertaken.

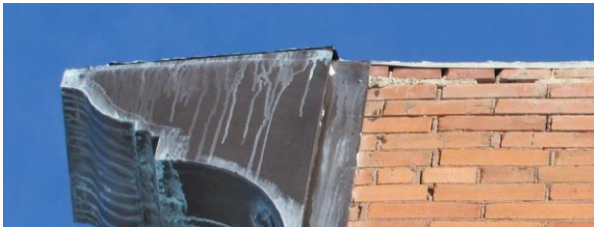
*Fig. 13 — The Stoop, Rouleau
(M. G. Miller, 2011)*

In Rouleau for example, the masonry parapet at The Stoop (Figure 13) shows signs of mortar loss, discontinuous parapet cap, and the dislodgement of bricks. In certain circumstances, deterioration precipitated by water infiltration has reached such an advanced stage that complete disassembly of the parapet and rebuilding it in kind may be the minimum intervention.

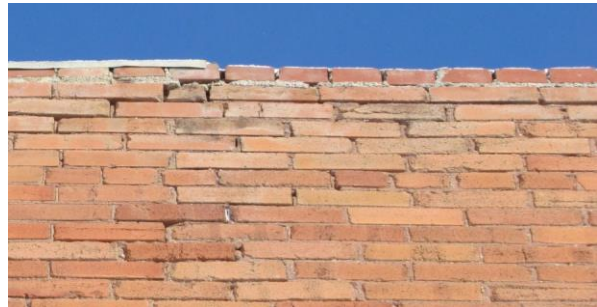
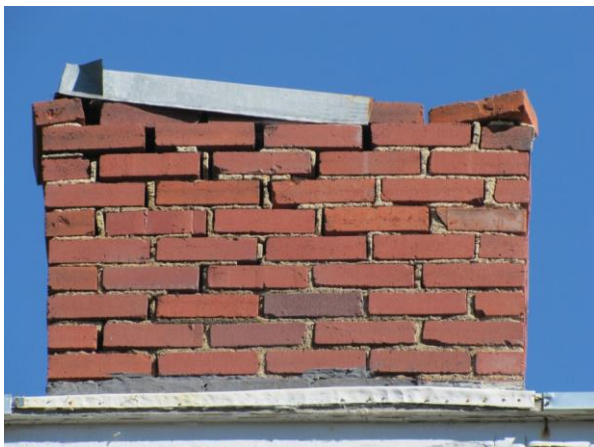
*Fig. 14 — The Village Centre, Chaplin
(M. G. Miller, 2011)*

(Figure 14) shows signs of mortar loss, dislodged bricks, and a dislodged metal cap. Just below the roof of the same building, a timber cornice (Figure 15) shows signs of localized deterioration that serves as a potential point of entry for water and/or unauthorized pests. Both of these areas are critical in relation to water management; both are somewhat isolated in their location making visual and physical access an added consideration to diligent water management.

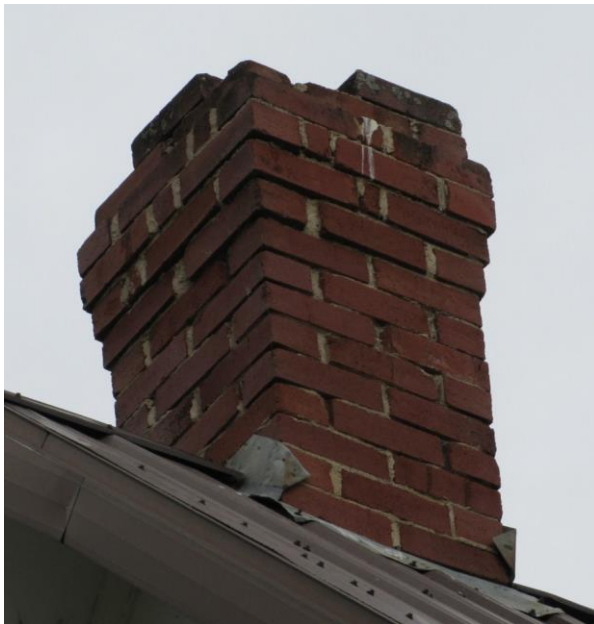
Fig. 16 — Scandia Heritage Church
(M. G. Miller, 2009)

The red brick chimney at Scandia Heritage Church (Figure 16), while showing signs of loose and missing capping bricks, would appear to warrant insitu (in its current location without disassembly) repair. This work in conjunction with a close-range inspection of the flashings are critical aspects of effective water management.

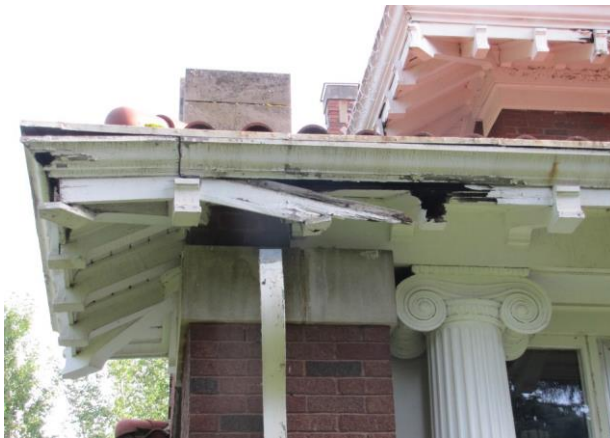
Fig.18 — Keyhole Castle, Prince Albert
(M. G. Miller, 2011)

The fascias are critical elements of a roof edge that serve to support eaves troughs. The effective maintenance of your eaves troughs is the number one method to prevent rain water issues from becoming greater than maintenance.

To start with, fascias and soffits do not like water! If your water collection and dispersal system is working well, then your fascias and soffits are generally protected. However, some water running down the roof surface

There are however, three key steps that you can take as part of your effective water management system:

1. Keep those eaves troughs clean;
2. Keep wood fascias and soffits caulked and painted; and
3. Keep unauthorized animals and insects away!

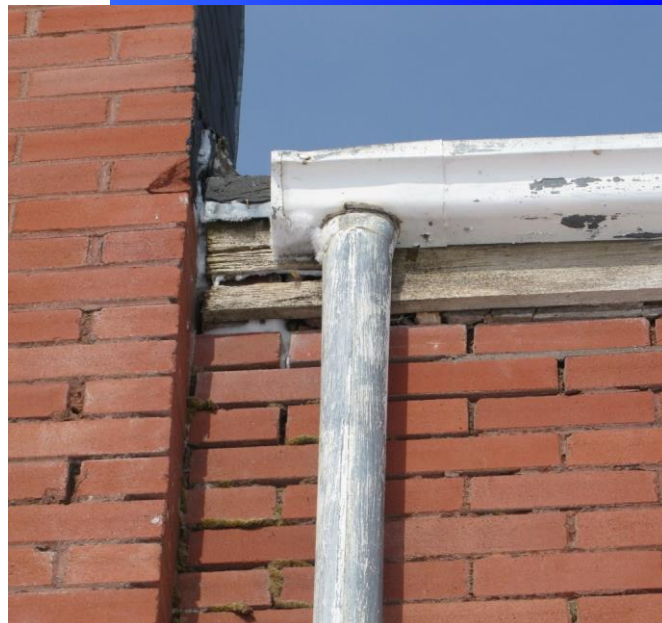
Fig. 21 — Khedive Recreation Centre, Khedive
(M. G. Miller, 2011)

Outside of the ice and snow seasons, leaves, mud and debris can block the drains in eaves troughs that direct the water to rain-water leaders. If no one takes the time to keep them clean, one of the three key steps that you could take in implementing an effective water management system will be forfeited.

Eaves troughs must be free enough to collect water from the roof surface if they are to be an effective component of water management. An eaves trough that falls short of the length required, will allow water to pass beyond the end of the trough thus exposing the fascia to deterioration. If there is no “drip edge”, water will find its way to locations where it will be more costly to manage.

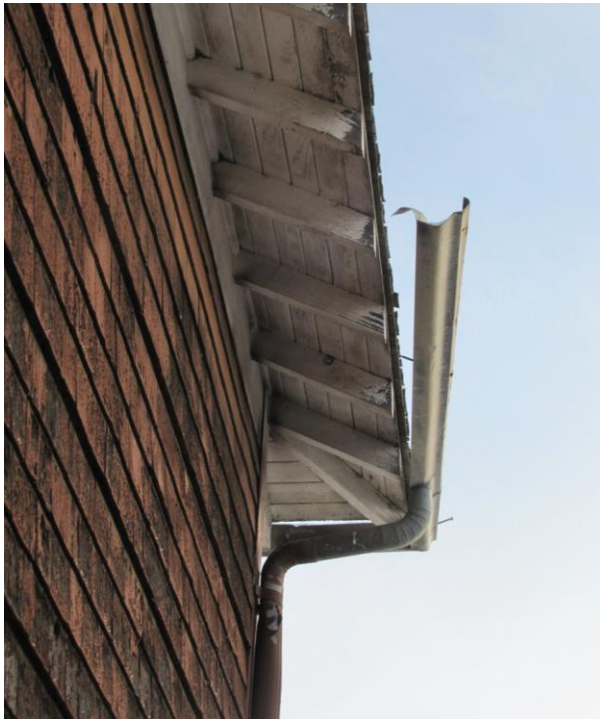
*Fig. 22 — Elk School, RM of Heart's Hill
(M. G. Miller, 2011)*

Detachment, for example, is worthy of mention here. Eaves troughs must be designed to take into account the volume of water to be carried; the placement of rain-water leaders; and the number of valleys to be accommodated. Older eaves troughs were often installed with spike-and-ferrules, however spikes do not allow for expansion and contraction and over time, the eaves trough will pull away from the building. Water then leaks between the eaves trough and the fascia board, cause the fascia to deteriorate (see Soffits and Fascias, page 14).

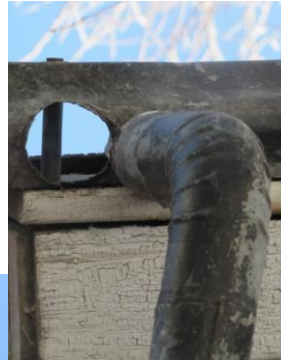
*Fig. 23 — Waddell Residence, Regina
(M. G. Miller, 2011)*

Connections between eaves troughs and rain-water leaders require continued maintenance to assure that drains are free of leaves and debris and that connections have not become loose. In addition to ensuring that drains are free from debris, of fundamental importance is making sure that the rain-water leader is actually connected to the eaves trough. In the absence of this connection, more water will be drawn to the fascias and soffits.

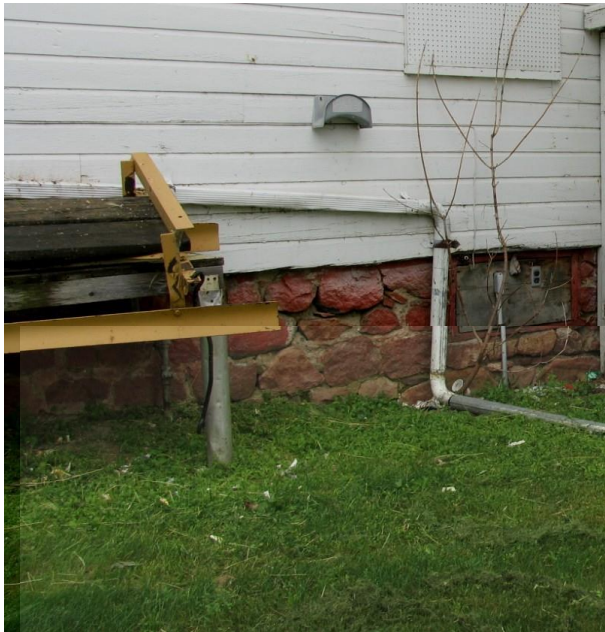
*Fig. 32 — Woseley & District Museum, Woseley
(M. G. Miller)*

Disposing water at the foundation is precisely where it should not be released. In regards to timber structures, this routing is an almost certain guarantee that the deterioration of the historic fabric will be accelerated.

With regard to the disposal of water at the base of a masonry structure, this can have serious adverse effects if water is allowed to enter cracks or voids left by failing mortar. Water that infiltrates cracks and crevices can freeze and as a result, expand within a confined space. The strength of the expansion can and often does exceed the capacity of the masonry to resist. Repeated freeze-thaw cycles can cause spalling and further cracking of the masonry to occur. This type of water infiltration, like the previous types of infiltration, are all preventable.
