Saskatchewan Heritage Foundation
CONSERVATION BULLETIN SERIES

Base

***B*ase** - This Conservation Bulletin is a resource guide for some of the most common foundation issues found in Saskatchewan heritage structures.

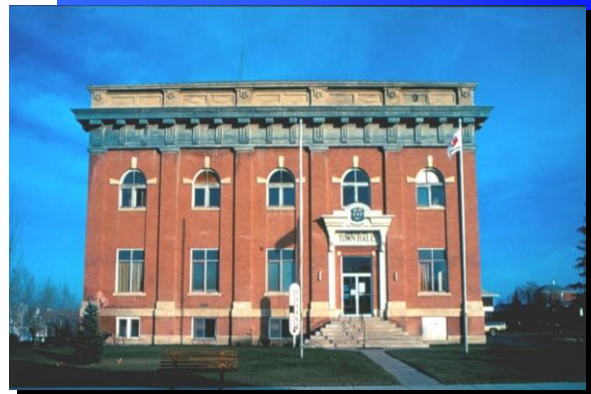
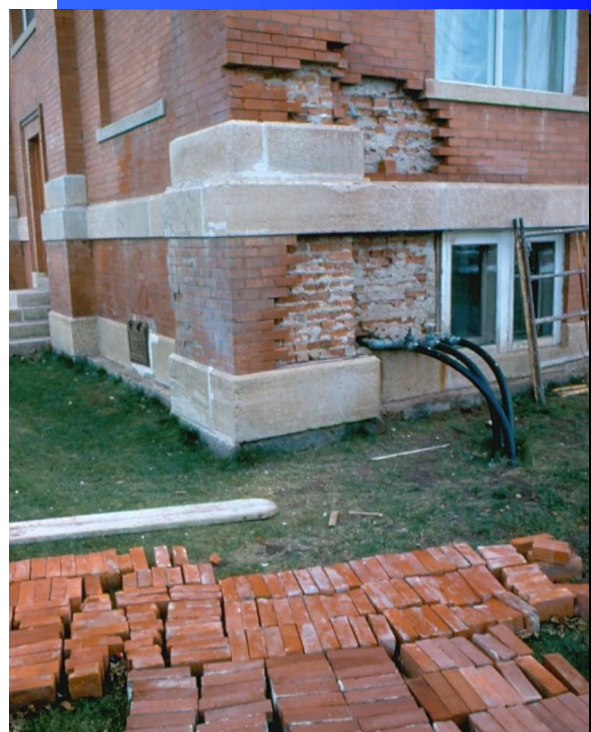
Town Hall / Opera House, Battleford SK

Battleford Town Hall / Opera House (1912) Water leakage at the top of the wall was a contributing cause to damage visible at the base of the building. <http://www.battleford.ca/buildings.html#thoh>

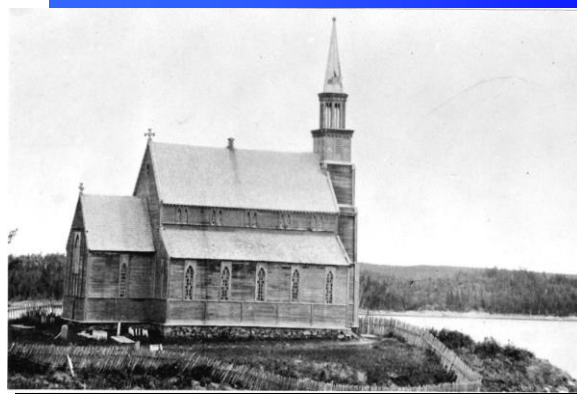
**Holy Trinity Anglican Church, Stanley Mission SK
(1854-1860)**

This late nineteenth century archival photograph shows the church on its the original stone foundation. As decades passed, the foundation began moving with shifting soil conditions and the heavy post and sill construction of the wall structure was deteriorating due to rising damp.

It is desirable to augment and retain original load bearing masonry or stone foundations, but this is not always possible due to a variety of site conditions including soil composition, site drainage characteristics, and load bearing requirements. At Stanley Mission's Holy Trinity Church (1854-1860), for example, the original stone foundation was replaced with a combined stone and cement foundation to provide an above-grade appearance compatible with the historic structure while increasing stability in areas not visible and below-grade for greater long-term stability.

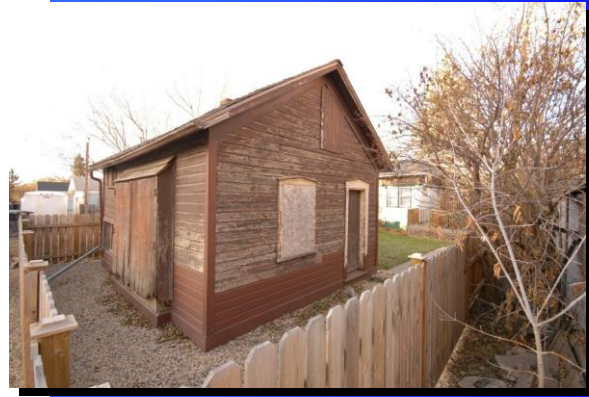
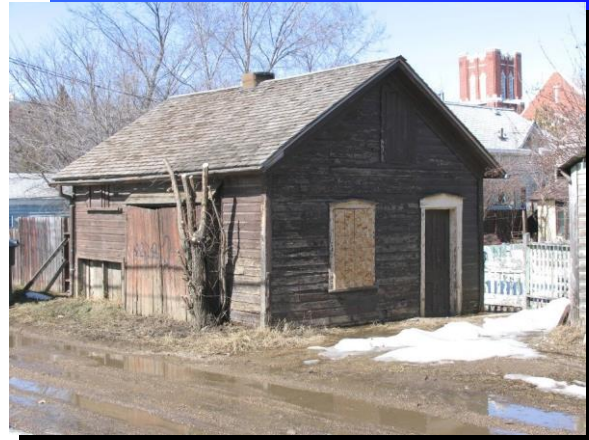
Trounce Residence / Fehr

While historic buildings often settle over time, raising the grade level around a building through the addition of extra soil or organic materials can also give the appearance of the structure sinking further into the ground. Building settlement combined with an elevated site at the Trounce Residence in Saskatoon allowed water to potentially flow into the building or seep into the lower structure and cause water-related deterioration. The site has now been appropriately graded and drained.

Trounce Residence (1883) is the oldest existing building in Saskatoon.
http://www.saskatoonheritage.ca/designated/trounce_house.html

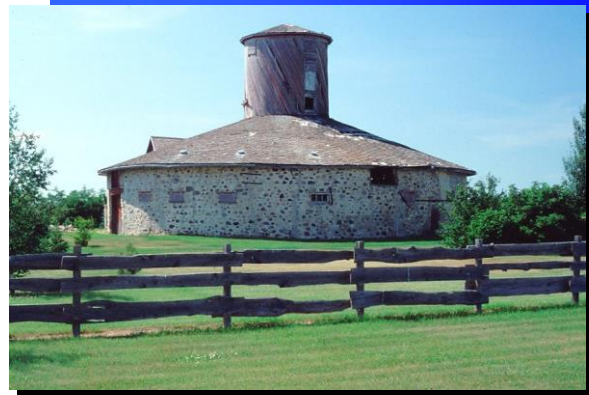
Bell Farm / Bruce Neill

Bell Farm (1882), **Indian Head SK** - no longer used as a horse barn, the altered temperature and humidity levels combined with poor maintenance to enable cold penetration and deterioration of the structure to the point where it was unsound. Fortunately, the community has rebuilt the structure with improved foundation, wall and roof systems.
<http://www.bellbarn.ca/history.php>

The Bell Farm barn (opposite) in Indian Head represents a type of historic structure that, as a result of time, history and the changing nature of the farming economy, was left unused. This impacted foundation conditions.

The National Trust for Historic Preservation publishes a "Barn Aid Series" (Barn Aid #1: Barn Foundations is available at <http://www.preservationnation.org/issues/rural-heritage/barn-again/additional-resources/2008-BA-Catalog.pdf>) - the series identifies that damage to barn foundations due to frost heave can occur when a barn is no longer used for livestock which causes a drop in the inside temperature; when this is combined with poor site grading to drain water away from the building, unrepaired eave troughs, and windows and doors left open during the winter, cold penetrates into the interior of the barn structure allowing moisture in basement walls and floors to freeze.

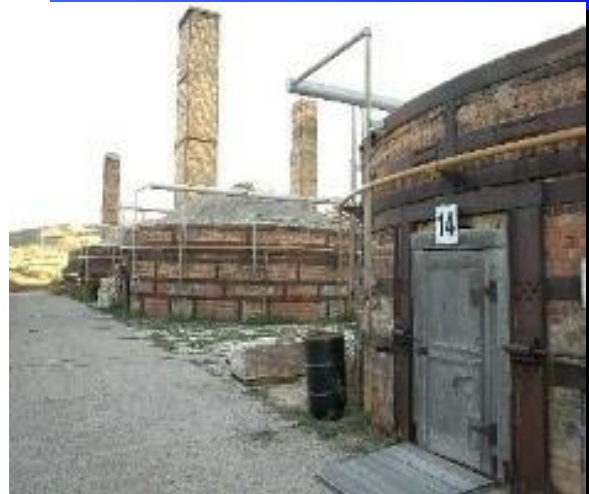
Claybank Brick Plant / Korvenmaker

Claybank Brick Plant, (1912) near **Avonlea SK** - The kilns are no longer used and the soil around the kilns has cooled; this has combined with exceptionally high ground water levels to result in increased dampness and efflorescence on the kilns' brick wall.
<http://www.tpcs.gov.sk.ca/Claybank>

Foundation damage might be the result of material failure due to a weak or deteriorated cement mix or inadequate design; but damage can also result from many other factors such as: inadequate site drainage, soil settlement, a high water table, tree roots, poor eave trough maintenance that concentrates water saturation, soil conditions, or unrelated activity adjacent to the site which is causing vibration and settlement. Additional causes of foundation deterioration could also include: subsurface ground movement, rising damp, improper site grading, fungal rot, condensation due to poor ventilation, insect and vermin infestations, and the proximity of vegetation and related irrigation systems to foundations. Changes to a structure's surroundings or function can also result in negative impacts on foundations. For example, a change of the type of occupancy could result in increased loads, new openings in the structure, interior climate change that might alter normal moisture content levels. Although many Saskatchewan heritage buildings have been continuously occupied, a change of use has impacted a variety of historic structures that have undergone dormant periods where they have remained unheated and poorly maintained especially during the winter. The beehive shaped kilns at the Claybank Brick Plant National Historic Site near Avonlea provide an example of the impact of a change of use. Once an industrial site where the kilns were regularly heated to extreme temperatures during the brick manufacturing process, the site is now a tourist attraction. The kilns are no longer used and the soil around the kilns has cooled; this has combined with exceptionally high ground water levels to result in increased dampness and efflorescence on the kilns' brick walls.

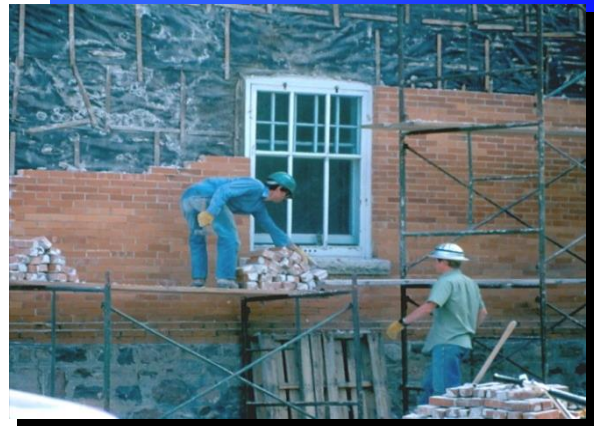
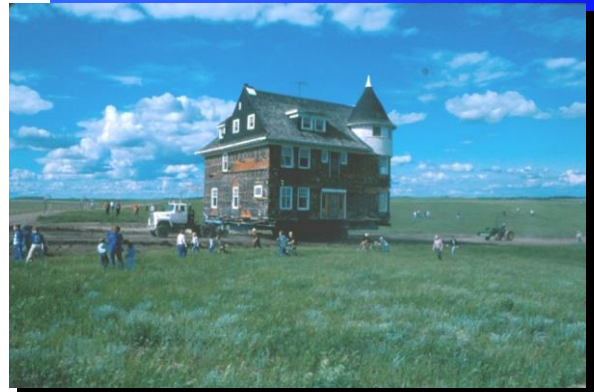
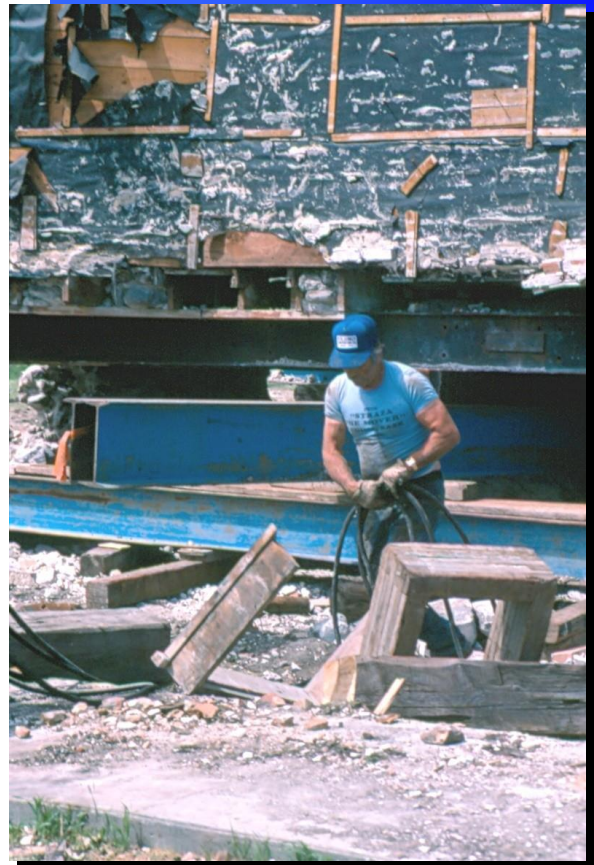
Banbury Residence, Wolseley SK (1905) built by Edwin Banbury, founder of the Beaver Lumber Company. The brick wall facing was removed prior to relocation of the building across town. The brick was then reapplied and the building restored for use as a restaurant and inn.
<http://www.banburyhouse.com/>

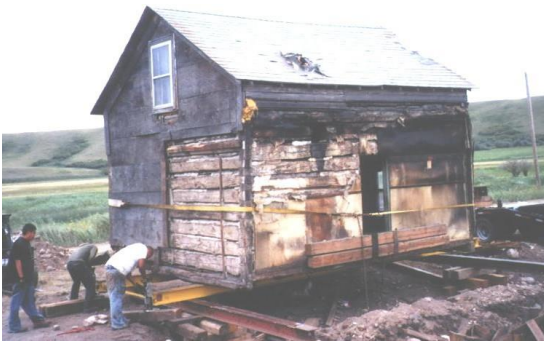
Ensuring that a foundation rises above grade level to provide clearance between ground cover and the wall structure is an issue sometimes faced in historic buildings, especially smaller structures without basements or crawl spaces. Historic log houses at grade level or on low foundations are also subject to deterioration as noted in the Edwards Log Home (pictured) originally located in the

Arm River Valley near Findlater, Saskatchewan. Because the house was built on grade, all bottom logs rotted and required replacement due to water damage.

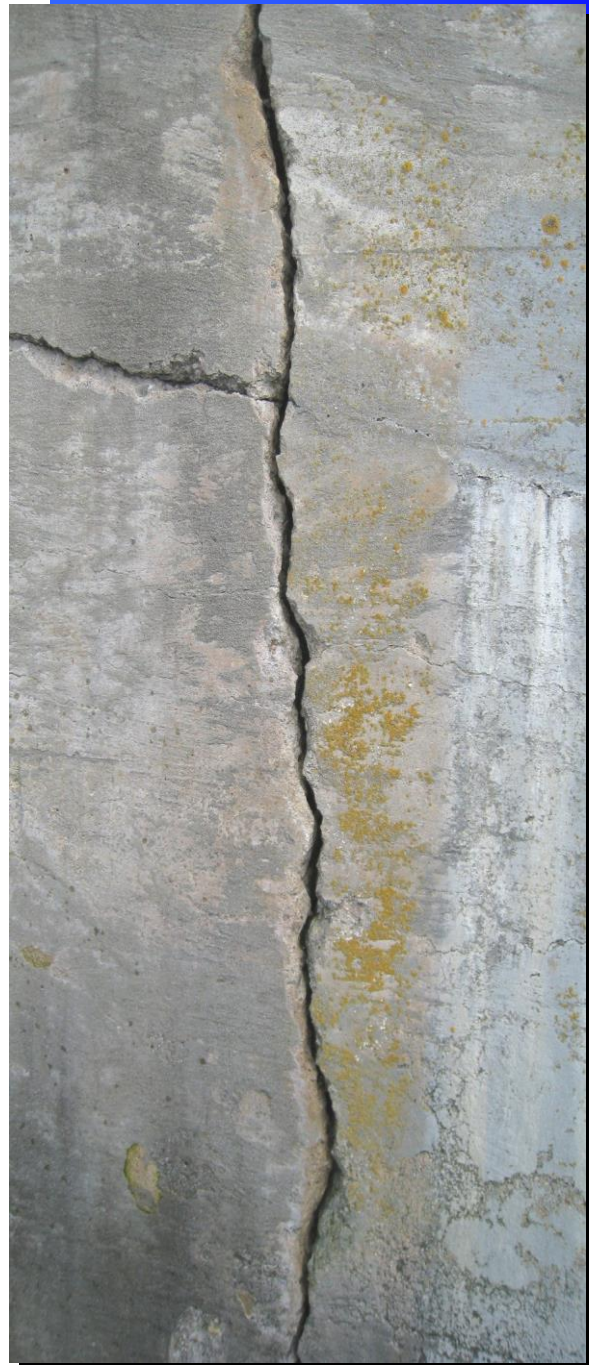
Typical Vertical Foundation Cracking / Zelmer

Vertical, shrinkage, expansion and settlement cracks - does crack widen at the top or bottom, does it radiate diagonally from an opening in the foundation. In addition to foundation replacement, there are many methods of treating crack areas depending on the severity of the situation, including: polyurethane foam, flexible sealants, caulks, grout, bentonite, and other commercial waterproofing and sealant applications.

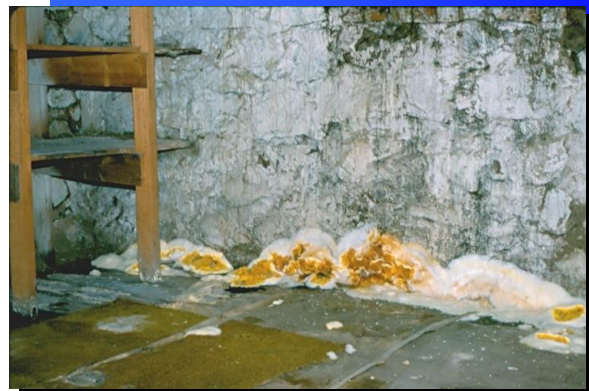
Foundation Mold / Korvenmaker
