CONSERVATION BULLETIN SERIES

Doors & Entrances

Doors and Entrances - This Conservation Bulletin is a resource guide for some of the most common issues surrounding approaches (also referred to as “Treatments”) involving historic doors and entrances in Saskatchewan. These guidelines provide information to anyone planning, designing and/or undertaking any type of work on doors and entrances that have been identified as character-defining elements. These guidelines also discuss examples from sites throughout Saskatchewan with a view towards raising awareness of the potential impact of change on heritage values when doors and entrances are altered.

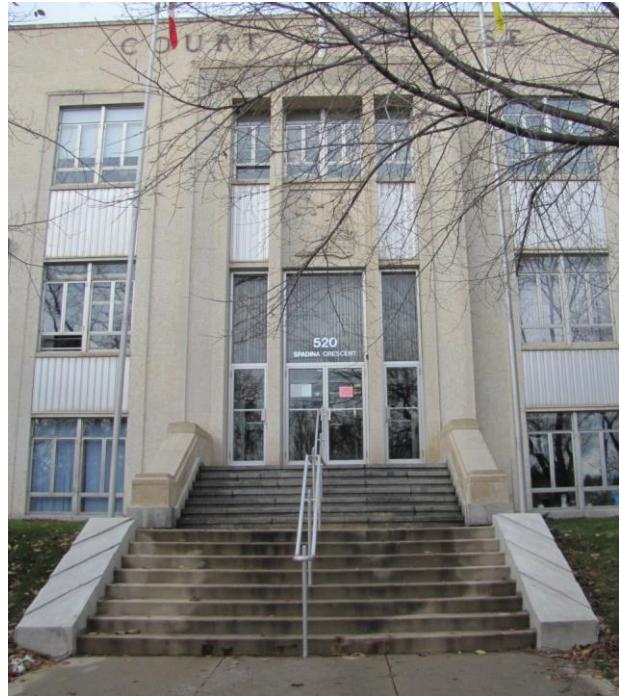
The Court of Queen's Bench building in Saskatoon (see Figs. 1 and 2) illustrates the impact that alteration of the principal entrance on Spadina Avenue will have on the appearance of this historic court house. The main entrance has been relocated to a new addition on the west side of this building and the original principal entrance has been removed.

Fig. 1— Court of Queen's Bench, Saskatoon
(Photo: M.G. Miller, 2010)

Fig. 2— Court of Queen's Bench, Saskatoon
(Source: H. D. H. Architects, 2011)

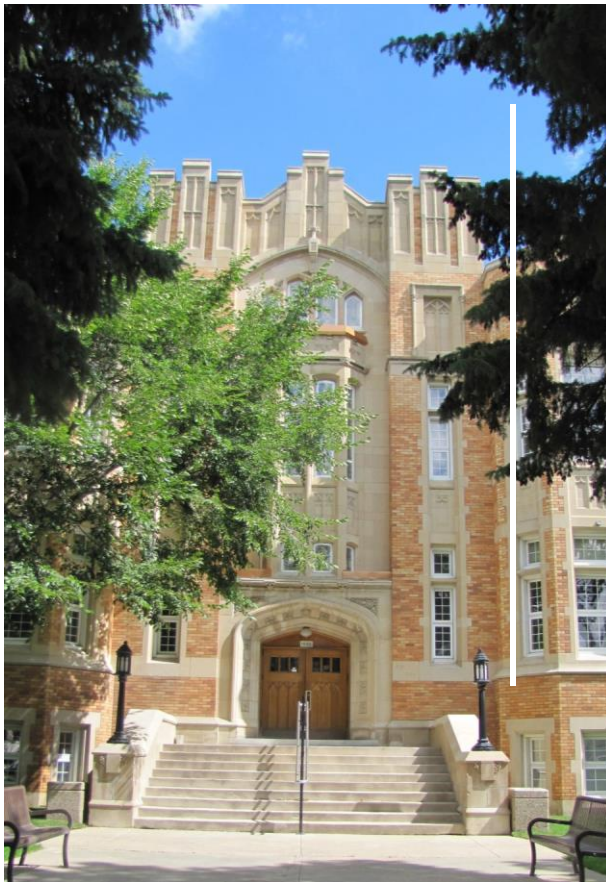
Fig. 3 —former Normal School, Saskatoon (M. G. Miller, 2011)

For example, the principal entrance to the former Normal School in Saskatoon (Fig. 3) is defined by the layout of its forecourt and a

setting which clearly establishes the importance of this entrance compared to other secondary entrances.

In the case of the former Saskatoon Normal School, the doors are compatible with the character of the historic place. In contrast, both the doors and windows of the Prince Albert Court House are replacement units that result in a distinct change to the heritage character of the building.

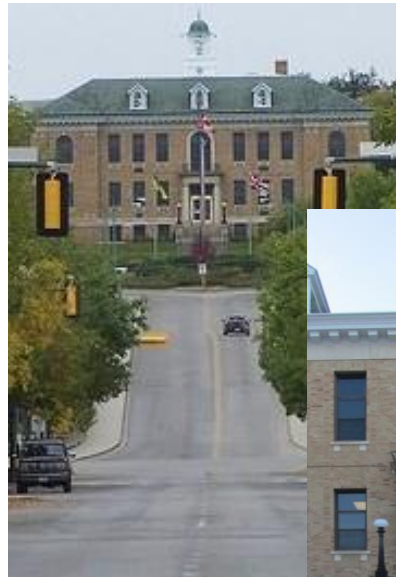
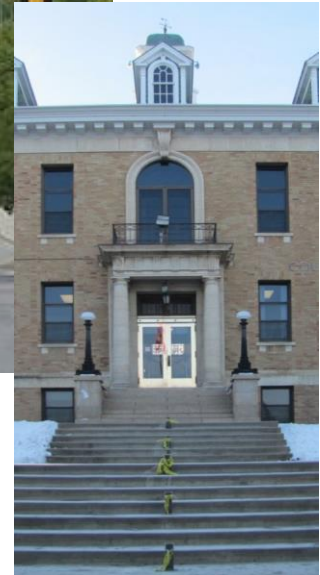
Similarly, the ascending stairs of Prince Albert's Court House (Figs. 4, 5 and 6), which are symmetrically and centrally located, provide a focal point from Central Avenue.

Fig. 4 —Prince Albert Court House, Prince Albert

Fig. 5 —Prince Albert Court House, Prince Albert (M. G. Miller, 2011)

Fig. 6 —Prince Albert Court House, Prince Albert (Photogelatine Engraving Co. Ltd. (Ottawa, Ontario))

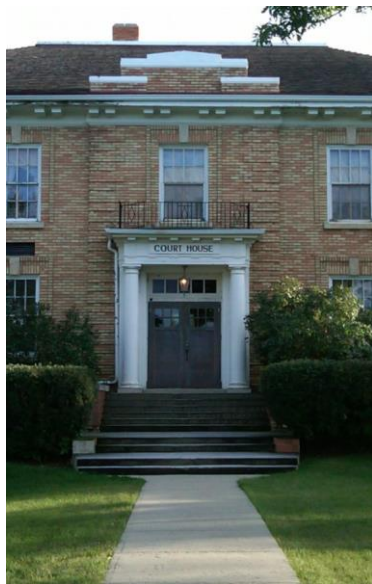
Doors and entrances that are highly compatible with the original intent are evident in the Assiniboia Court House, where Fig. 7 reflects the 2011 condition and Fig. 8 illustrates one of the original drawings prepared by architect Maurice Sharon.

Fig. 7 — Assiniboia Court House

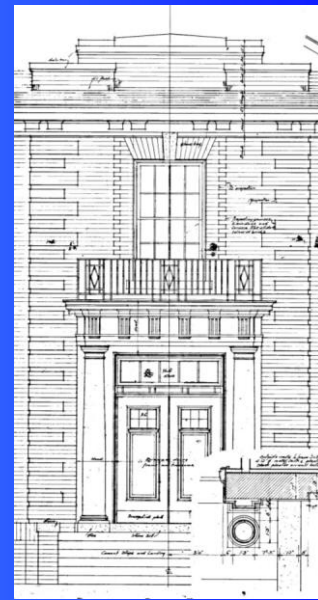
Fig. 8 — Assiniboia Court House (Original elevation drawing: Maurice Sharon Architect, 1930)

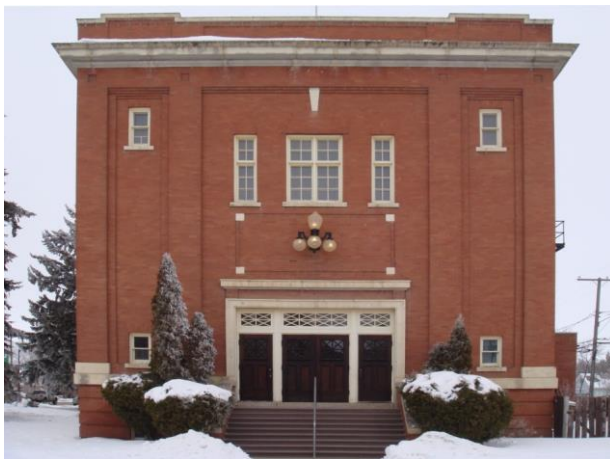
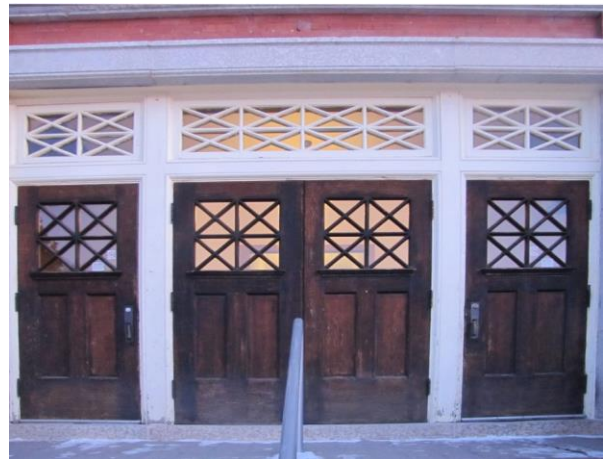
Fig. 10 —Melville City Hall, Melville
(M. G. Miller, 2011)

As an example, since the original secondary doors at the Melville City Hall (Figs. 10, 11 and 12) still remain on the property, the appropriate work to be undertaken would start from preservation of the character-defining form and features of these doors. The addition of weather stripping, adjusting hardware and sealing cracks and joints in the doors are important and energy-efficient preservation measures.

Fig. 11 —Melville City Hall, original character-defining doors and entrance
(M. G. Miller, 2012)

*Fig. 12 — Melville City Hall, partial original drawing of Storey and Van Egmond Architects, 1912
(Drawing: The Heritage Conservation Branch files)*

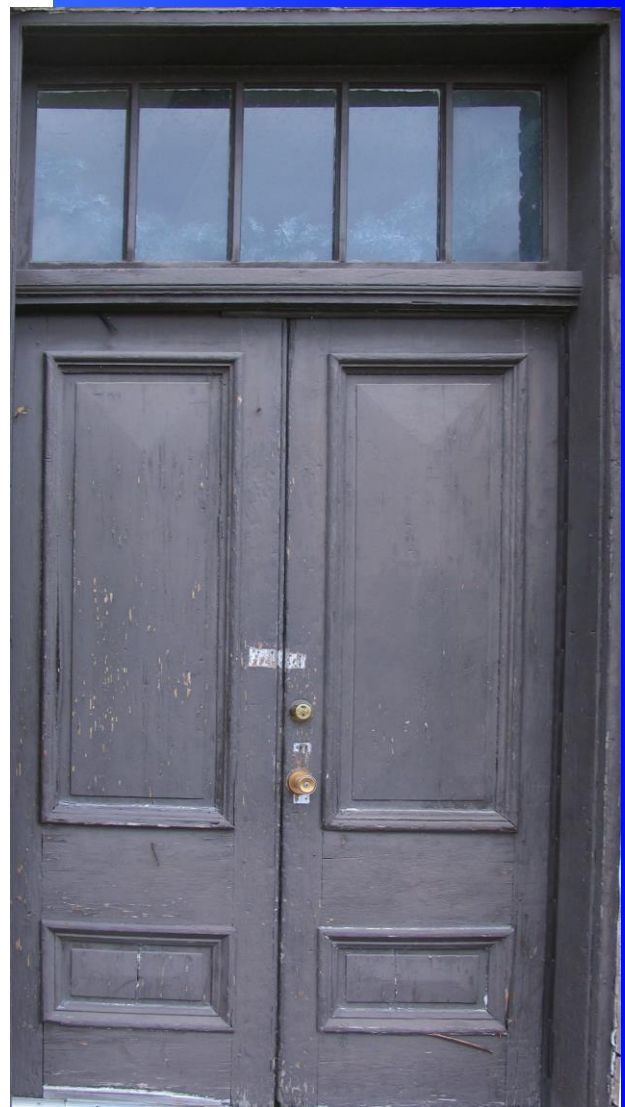
The secondary double doors at the McNaughton Stores building in Moosimin (Fig. 13) appear sufficiently sound to warrant the installation of weather stripping, limited paint removal, cleaning, adjustment of hardware and sealing of cracks and joints. Such work can contribute significantly to the physical integrity and energy efficiency of historic timber doors.

Fig. 14 — Raised-panel timber-frame doors with multi-light transom, McNaughton Stores building (1890) (Photo: M. G. Miller, 2011)

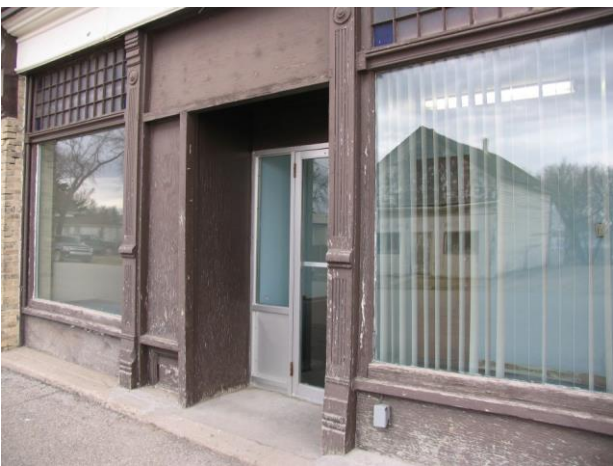
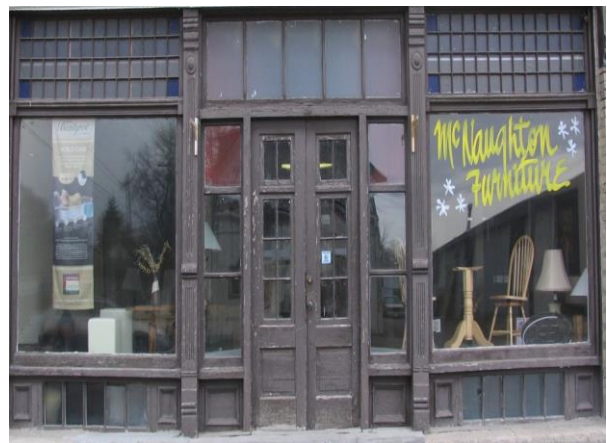
In relation to the McNaughton Stores building in Moosomin, the re-creation of the northern storefront (Fig. 15) can draw from the existing physical evidence in the southern storefront (Fig. 16) in order to reinstate the post 1890 appearance of the northern entrance.

Fig. 15 — McNaughton Stores (1890 addition)

If it were determined that the original 1890 storefront was of greater significance than the post 1890 condition that partially remains, one could elect to restore the storefront to its original appearance, which would require the removal of the flush entrance system that presently exists (Fig. 16) in favour of the recessed entrance that existed in 1890 and to a certain extent, still remains on the property today.

Fig. 16 — McNaughton Stores (1890 addition)

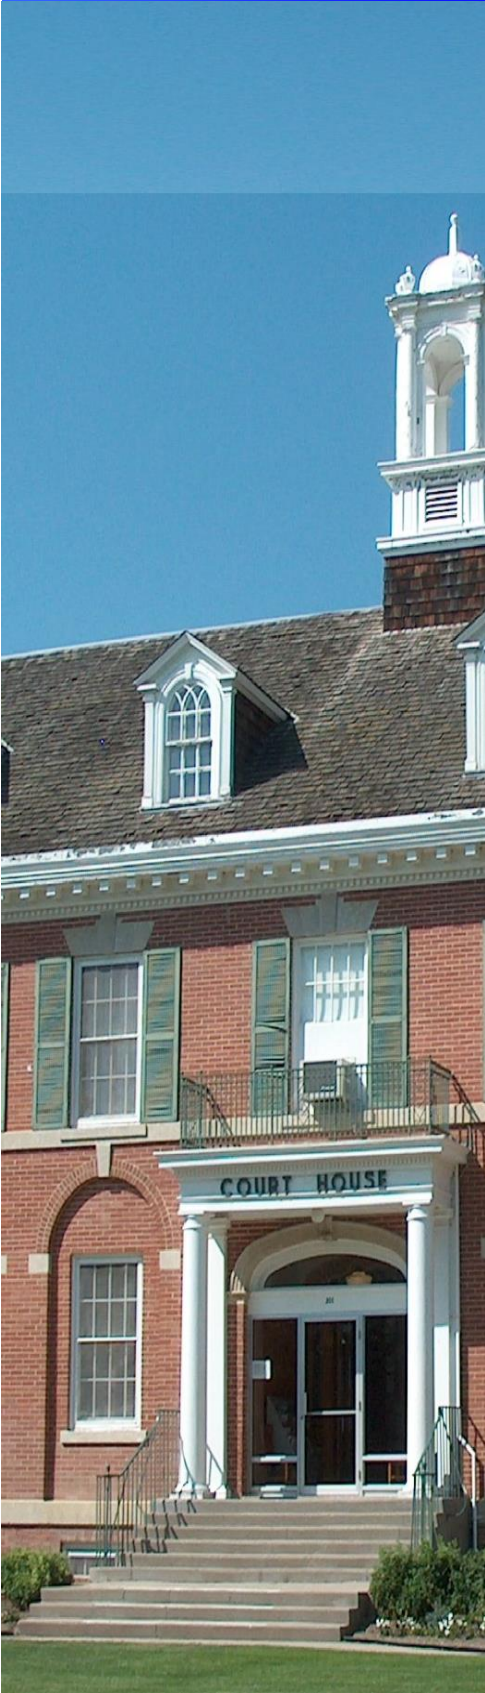
The situation of the Weyburn Court House raises different issues. Here, there is no physical evidence that would guide the restoration of the front doors. The existing replacement entrance is materially, architec-

turally and functionally incompatible with the historic character of the place.

However, the original plans are available, which show more clearly the design intent for the doors and entrance. The original entrance consisted of a double raised-panel timber door with narrow sidelights and slender columns in between.

The proposed design would create a double-door entrance system without sidelights and with additional flanking columns which did not exist previously. The squat appearance of the proposed doors along with the elimination of proportionate sidelights and the introduction of reorganized elements would alter the character and appearance of the entrance system considerably. In this case, both the existing (Fig. 19) and the proposed entrance system (Fig. 17) would not meet the Standards and Guidelines.

Fig. 17 — Weyburn Court House—proposed entrance doors prepared by Alton Tangedal Architect Ltd. & Walker Projects Inc., (2011)

Fig. 18 — Weyburn Court House—partial original elevation prepared by M. W. Sharon Architects (1927)

Fig. 19 — Weyburn Court House (above) —partial existing elevation showing front entrance (M. G. Miller, 2011)

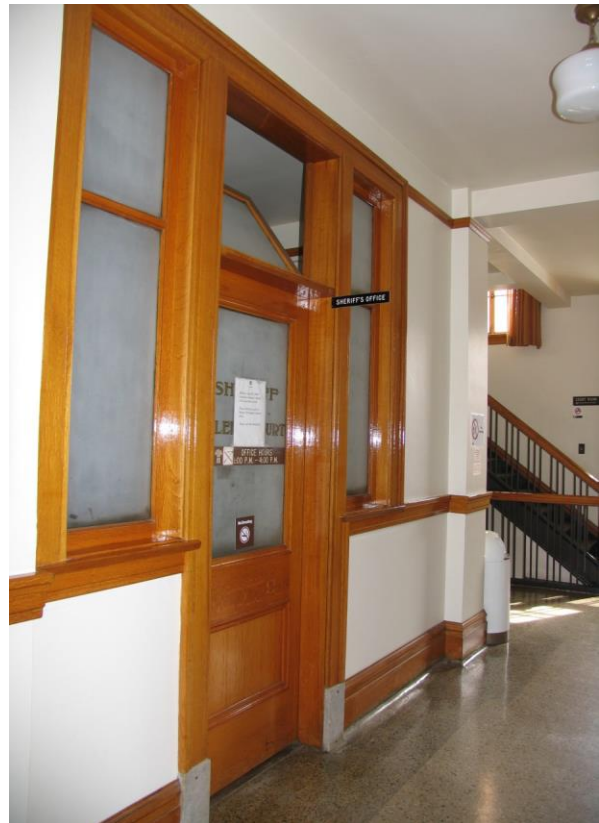
Fig. 22 — Assiniboia Court House—interior door (M. G. Miller, 2011)

Most of the doors and entrances depicted in this bulletin are exterior systems but there are also historic places whose interior doors are character-defining elements (Fig. 22).

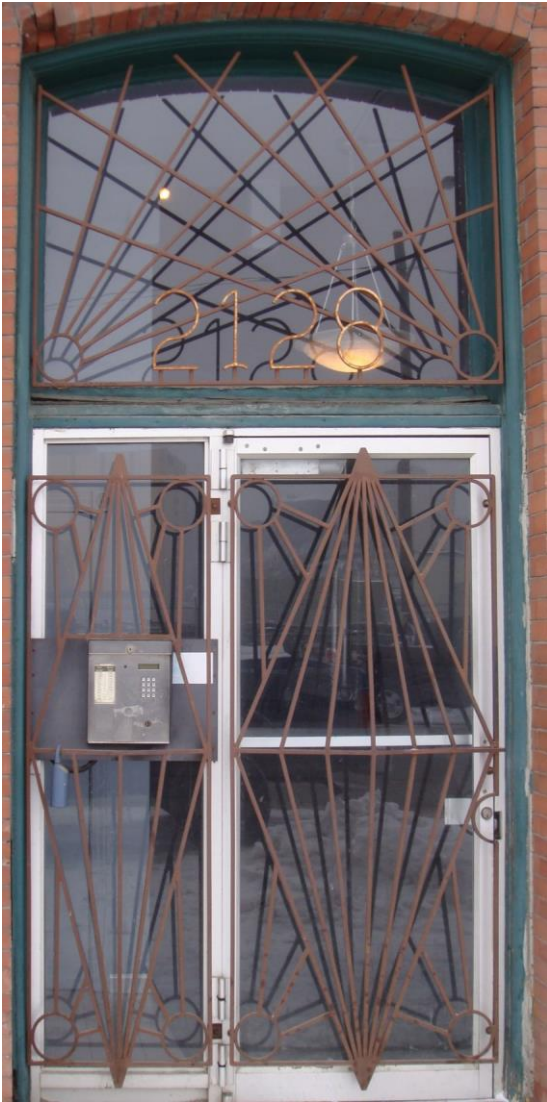
For the Ackerman Building Regina, the requirement for increased security has introduced a design element that may add interest to an aluminum-framed replacement door set within a timber frame. While the security grill can be said in this instance to be “reversible”, the aluminum door remains architecturally, materially and visually out of character of the place (Fig.23).

Fig. 23 — Ackerman Building, Regina, replacement entrance door

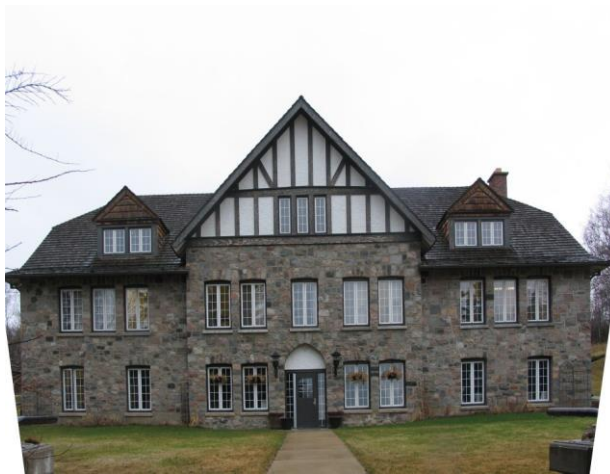
Fig. 26 — Moose Mountain Chalet, Kenosee Lake, Moose Mountain Provincial Park
(M. G. Miller, 2011)

In relation to the Moose Mountain Chalet, for example, the total replacement of the original wood by PVC windows would not be an acceptable substitute material. Further, selecting the least expensive, readily available product often results in inferior materials that have a lower initial cost but a much shorter life-span.

The prominent double doors that once faced the lake at the Moose Mountain Chalet (Fig. 27) were replaced by a single door and flanking sidelights (Fig. 26) that has fundamentally altered the character of the entrance system.

Fig. 27 — Moose Mountain Chalet, Kenosee Lake, Moose Mountain Provincial Park
(M. G. Miller, 2011)

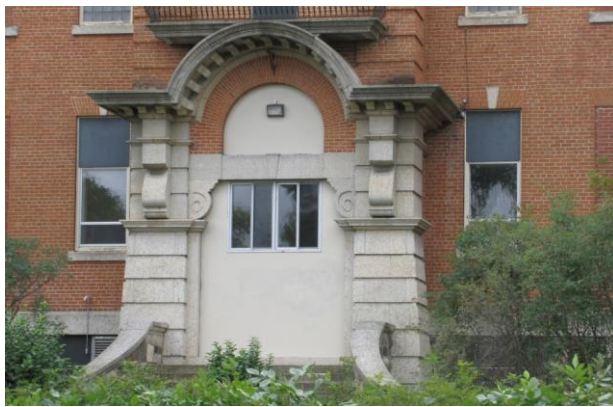
Fig. 29 — Prominent landmark, Prince Albert

From courthouses to schools, the introduction of replacement elements at the highly prominent part of building that makes up the ‘point of entry’ requires exceptional care. In the absence of care, evidence has shown that significant departures from a compatible design, such as that depicted in Figure. 29, typically produces visual effects that ultimately degrade the integrity of the historic place.

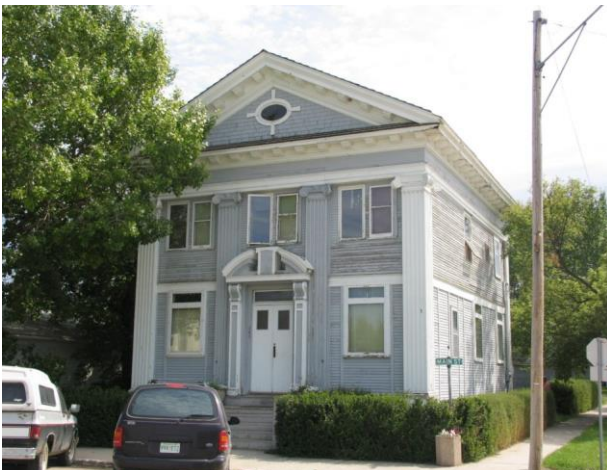
The replacement doors that were installed at the Bank of Commerce in Nokomis also erodes the historic character of this landmark institution (Fig.28).

Fig.28 — Bank of Commerce, Nokomis
(M. G. Miller, 2011)

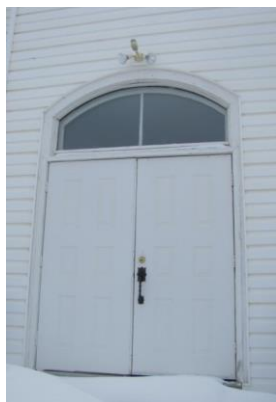
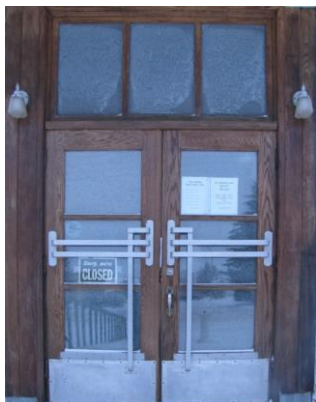
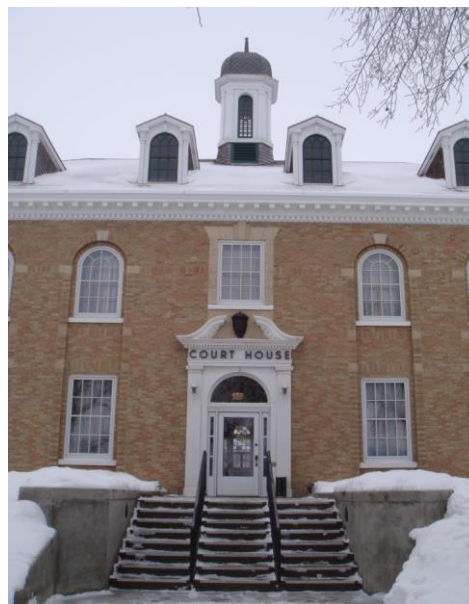
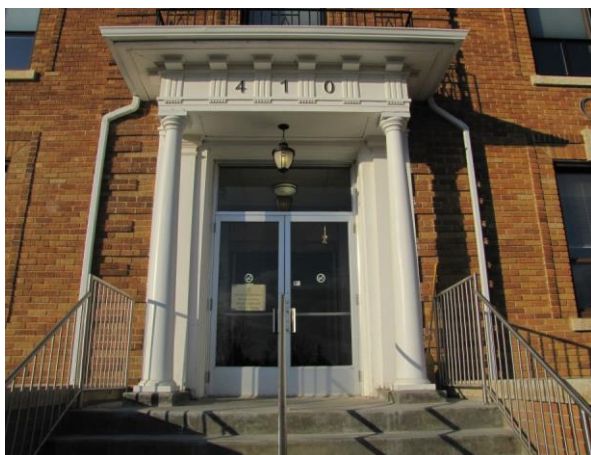
Replacement is a last resort, and should be ‘in kind’ in terms of style and materials. A common occurrence is to attempt to fit mass-produced ‘period-style’ doors that are out of keeping with the historic character of the property. Examples of this appear to include the front doors of St. Paul’s Bergheim Lutheran Church (Fig. 32); Estevan Court House (Fig. 34); and Wynyard Court House (Fig. 31).

Fig. 32 — St. Paul’s Bergheim Lutheran Church (M. G. Miller)

Fig. 33 — St. Walburg Museum (M. G. Miller)

Fig. 34 — Estevan Court House (M. G. Miller)

Fig. 31 — Wynyard Court House (M. G. Miller, 2011)

Historically, these doors would have been constructed of timber, thus the use of timber in any replacement door is essentially the baseline condition that should be met. This is reflected in the Standards and Guidelines by the frequent use of the terms “in kind” when referring to the manner in which replacement elements should relate to the original fabric.

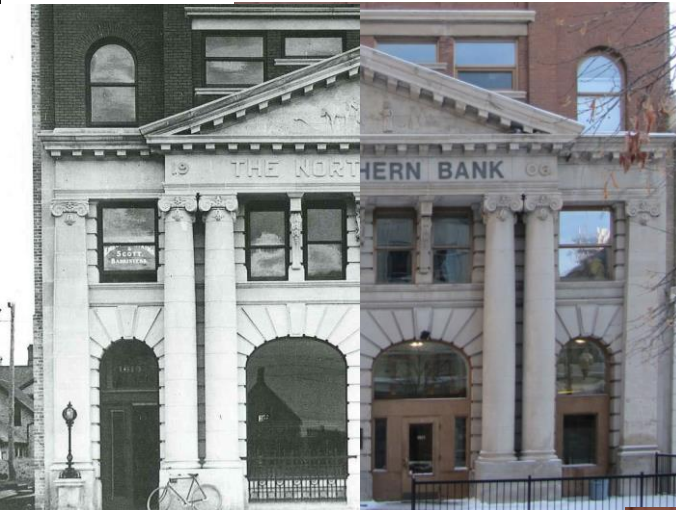
The Northern Crown Bank (Fig. 35) is the oldest commercial building in Regina's central business district whose character-defining street façade was historically comprised of entrances that flanked the central projecting frontispiece within the two central glazed openings. All of the doors and windows have been altered from their original appearance with the tall flanking double doors converted from entrances to windows and the central windows largely infilled by visually 'heavy' construction (Fig. 36).

exterior appearance in a way that would not satisfy the Standards and Guidelines. The Standards and Guidelines require that any change, whether that be preservation, restoration or rehabilitation, shall not diminish or adversely affect heritage values.

Fig.35 — Northern Crown Bank (1910), Regina (Saskatchewan Archives Board, Album, p.5, Cat # 2488)

Fig.36 — NCB (M. G. Miller, 2011)

Fig.37 — Northern Crown Bank (1906) (SAB)

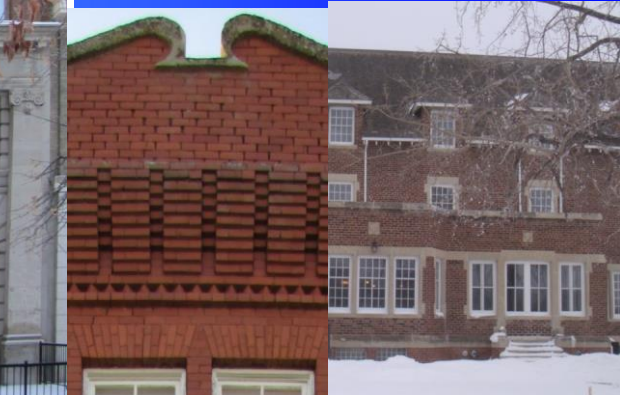
Entrances are often altered to accommodate a different use internally. The original entrance at Harding House (Fig. 39) is another example of an original doorway that was removed to allow the installation of a window. Converting a doorway to a window opening

Fig. 39— Harding House, Regina (M. G. Miller, 2011)

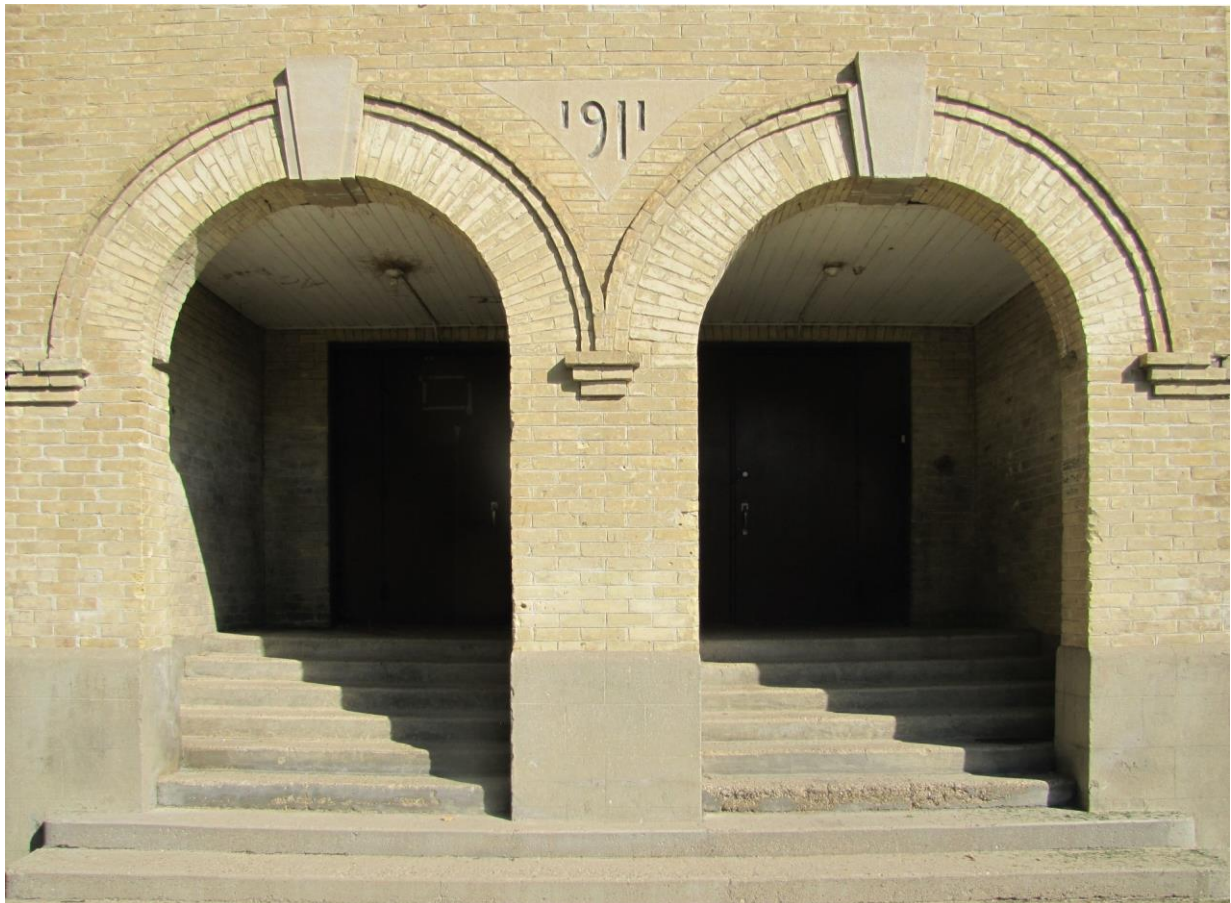
In relation to the subject of this bulletin and for illustrative purposes only, it may be said that occasionally, an entrance will speak clearly about the interior organization or the function of the place. Consider for example, the entrance at the old Central School in Fort Qu'Appelle (Fig. 41).

In this instance, the first two-storey, four-room school designed by renowned Regina architects Edgar Storey & William Van Egmond featured a symmetrical plan with back-to-back staircases divided to reflect the division of girls from boys at the time. This demarcation of use and/or gender is further expressed on the exterior at the main entrance where two connected arches frame deeply recessed doorways that are accessed by common and separate stairs.

The architectural expression of function at the entrance can therefore be said to reflect a "form follows function" design and at this heritage property, it can be said to constitute a character-defining feature of the place.

Fig. 41 — Old Central School, Fort Qu'Appelle
