Saskatchewan Heritage Foundation
Heritage
CONSERVATION BULLETIN SERIES

Roof

Roof - This Conservation Bulletin discusses roofs as architectural assemblies that have both functional and decorative elements that help define the architectural character of the historic building. Roof features include cupolas, parapets, chimneys, gutters, dormers, and bracketed eaves.

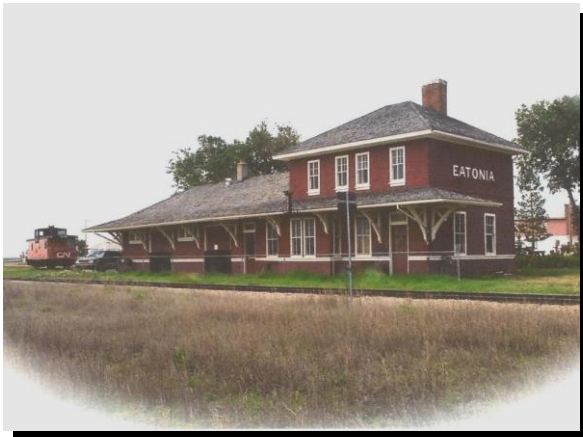
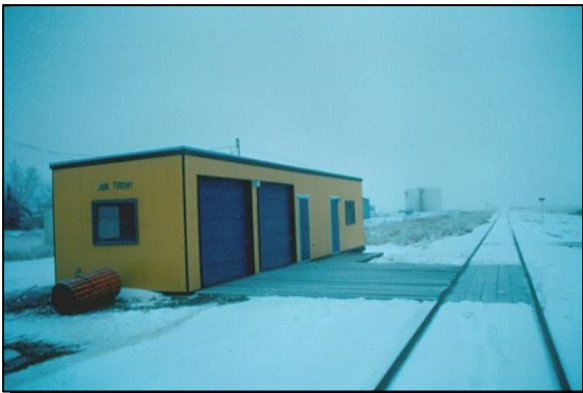
CNR Station (top); VIA Station, Eatonia SK

The railway station's architectural form and plan were determined by its function and eloquently expressed with decorative features such as the heavy overhanging eaves which also served many functional purposes.

Generous overhanging eaves provided shelter from the blistering sun and driving rain, and the ornate brackets divided the long expanse into sections that added privacy for those clustered below just off the busy platform. The overhang also protected luggage stacked on carts out of the rain. Under the beautiful overhang, loved ones found a space of privacy and intimacy to say hello or embrace in final farewell before leaving for war or places far from the safety of home.

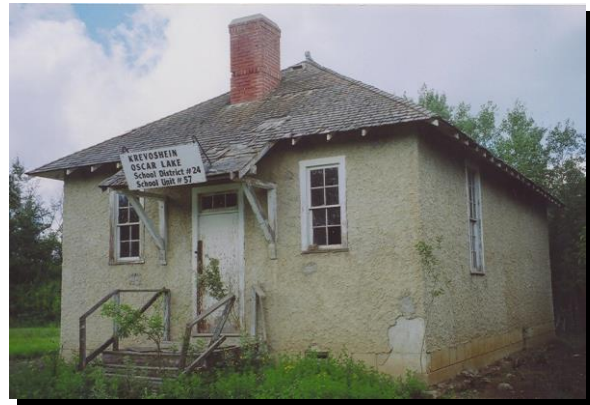
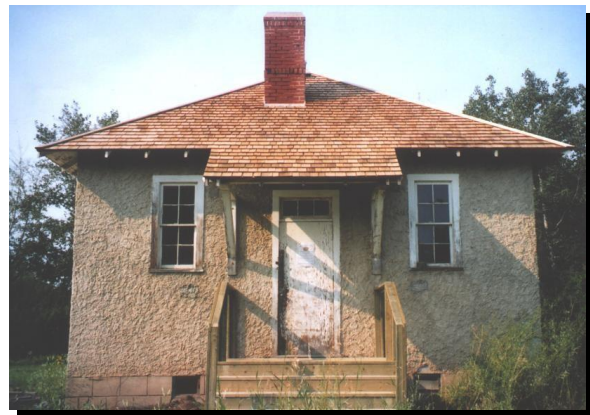
***Krivoshein / Oscar Lake School
Meeting Lake RM 466, near Hafford***

(top) *Before roofing repairs.*

(bottom) *After application of new wood shingles.*

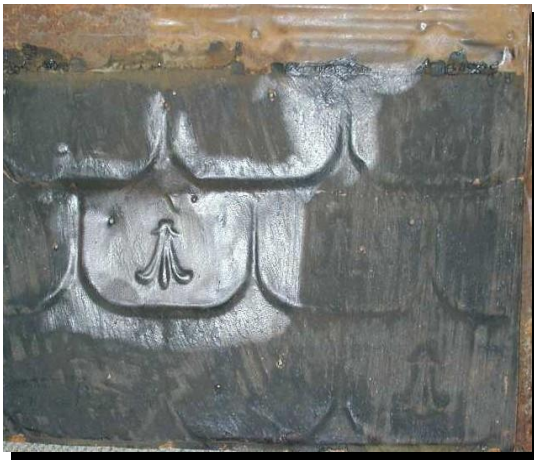
Town Hall / Opera House, Prince Albert SK
Fleur de Lys design (18 x 22 inches)

SAMPLES OF METAL ROOFING WHICH CAN STILL BE REPLICATED.

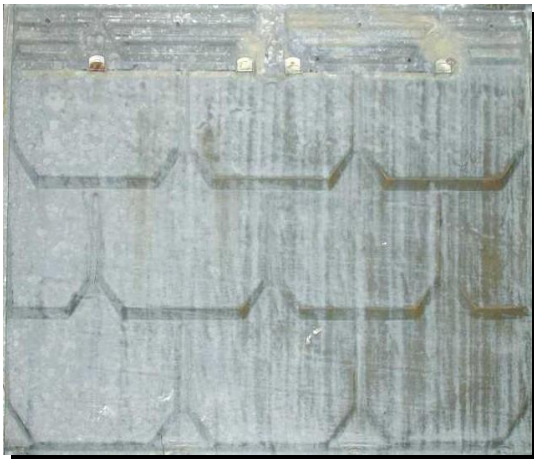
Philbert Residence, Meyronne SK
Roof shingle (18 x 22 inches)

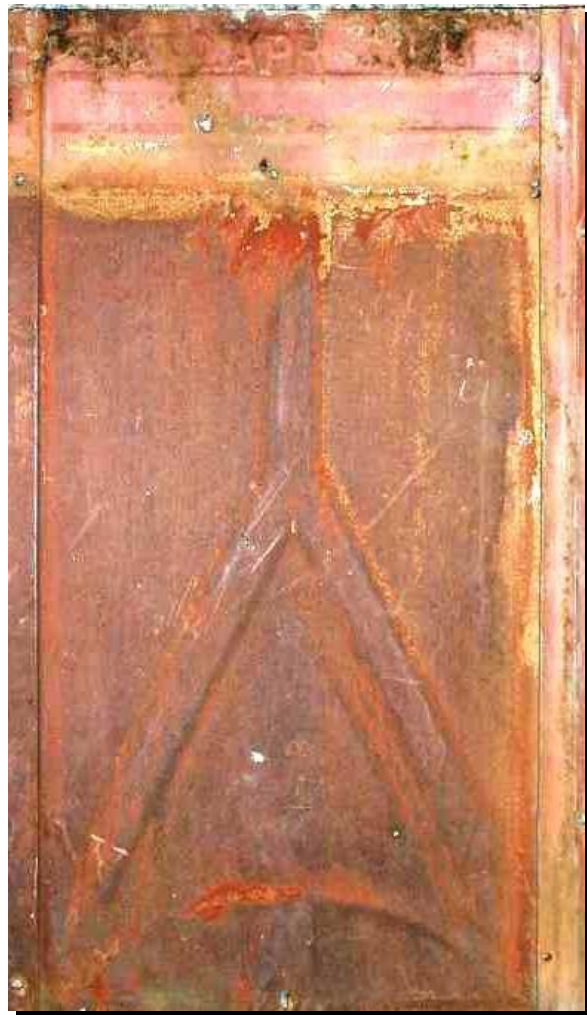
Land Registry Office, Battleford SK
Inverted "Y" design (9 x 14 inches)

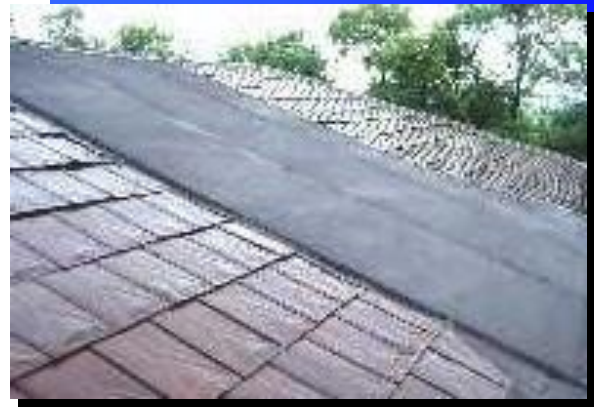
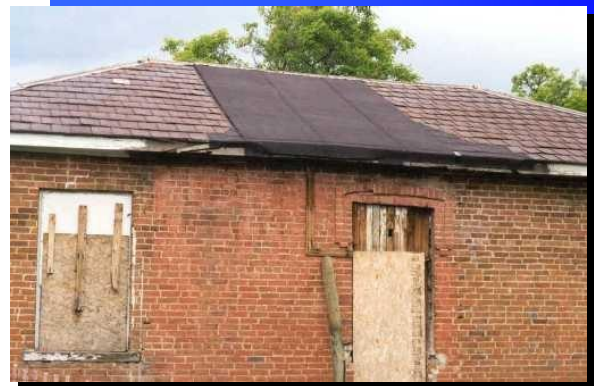
Land Registry Office, Battleford SK

Asphalt Patch on Metal Shingle Roof - changing from metal shingles to wood or asphalt significantly alters the appearance of an historic building.

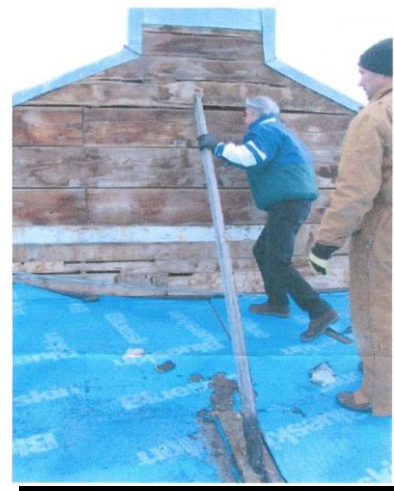
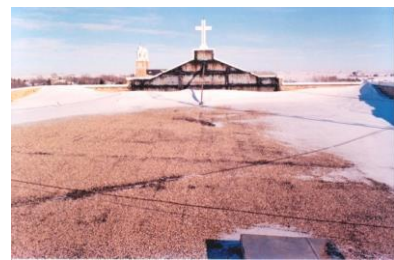
*Elementary School, Gravelbourg
Reroofing and parapet repairs*
