Saskatchewan Heritage Foundation CONSERVATION BULLETIN SERIES Window

indow - This Conservation Bulletin is a resource guide for some of the most common issues surrounding wood windows found in Saskatchewan heritage structures. It provides factual information to anyone considering replacing repairable wooden windows.

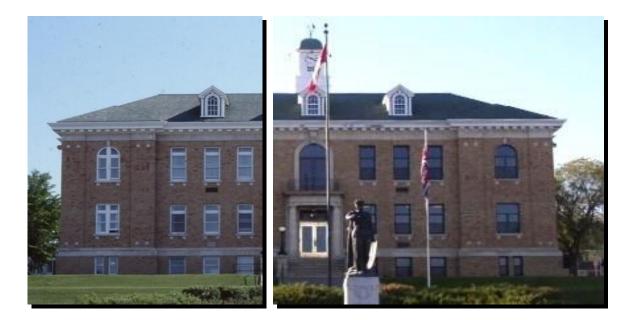
Court House, Prince Albert SK. - shown with the original white-framed wood windows (left) and the replacement black aluminum sealed units (right). Neither the colour nor the new window design replicates the original, thereby giving the building a very sombre appearance.

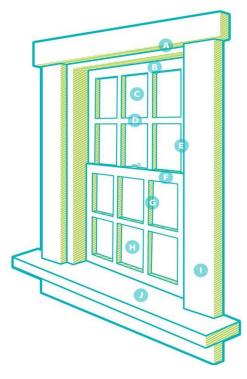
PARTS OF AN HISTORIC WINDOW

Forum Journal, 20, no. 2 (2006), National Trust for Historic Preservation; Illustration by mckibillo		
A. Jamb	Vertical or horizontal member that frames the window opening.	
B. Rail	Horizontal part of sash.	
C. Pane / Light	Glass held in place by glazing putty and metal glazing points.	
D. Top Sash	Upper section of window, may slide down to open.	
E. Stile	Vertical part of sash.	
F. Meeting Rail	One of two horizontal members in a double-hung sash which come together	
G. Muntin Strip	Separates panes of a window; shape provides a clue to the window's age.	
H. Bottom Sash	Lower section of window, typically slides up to open.	
I. Casing	The finished, often decorative, framework around a window.	
J. Stool	Interior shelf-like board against which the bottom rail of the sash rests.

Opposite Page - The basic parts of an historic window are illustrated on the previous page. Critical to this design, which clearly distinguishes historic from modern windows, is the presence of three-dimensional wood muntins that hold individual panes of glass. Imitation muntins, sometimes called grills, are an unacceptable alternative for historic buildings, as the proportions are almost always incorrect and their interior placement result in an awkward reflective appearance.

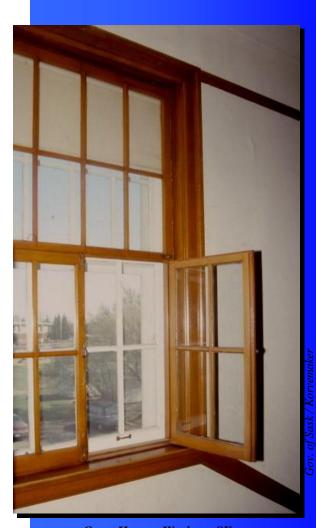
Court House, Weyburn SK Opening the Court House's casement window provides access to the double-hung primary window.

Interior casements have existed in the Weyburn Court House for over eighty years. Properly installed and maintained, they help to reduce drafts, reduce heat loss in the winter, improve energy conservation, and enable the introduction of fresh air on an as-needed basis.

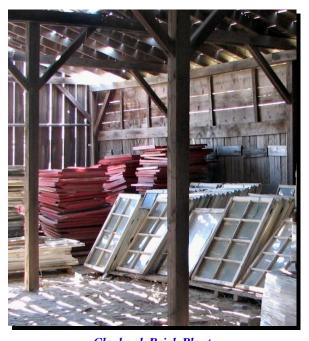
Claybank Brick Plant Salvaged historic windows are stockpiled to repair the many broken windows in the complex.

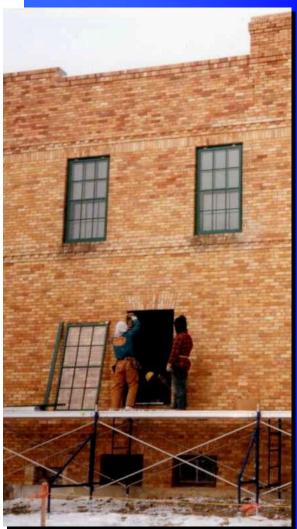
Claybank Brick Plant National Historic Site Bunk House, near Avonlea SK

Replacement replica wood storm windows are installed at the Bunk House / Heritage Visitor Centre

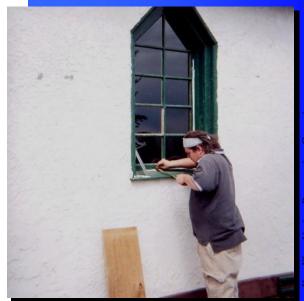
Key First Nation, near Veregin SK First Nations carpenters helped repair and selectively replace rotten wood sills at this church.

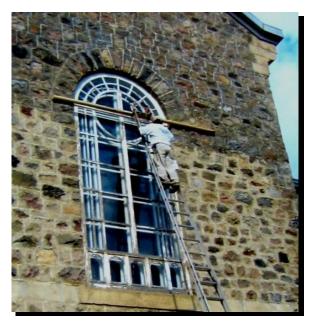
Sacred Heart RC Church. Lebret SK - A craftsperson who specializes in window repair and restoration can often perform basic work on site. Where deterioration is too advanced. it may be necessary to remove the window and repair it in a workshop.
