CONSERVATION BULLETIN SERIES

Brick Masonry

Brick Masonry - This Conservation Bulletin is a resource guide for some of the most common issues surrounding brick masonry on Saskatchewan heritage structures. It provides information to anyone considering the repair of historic brick masonry.

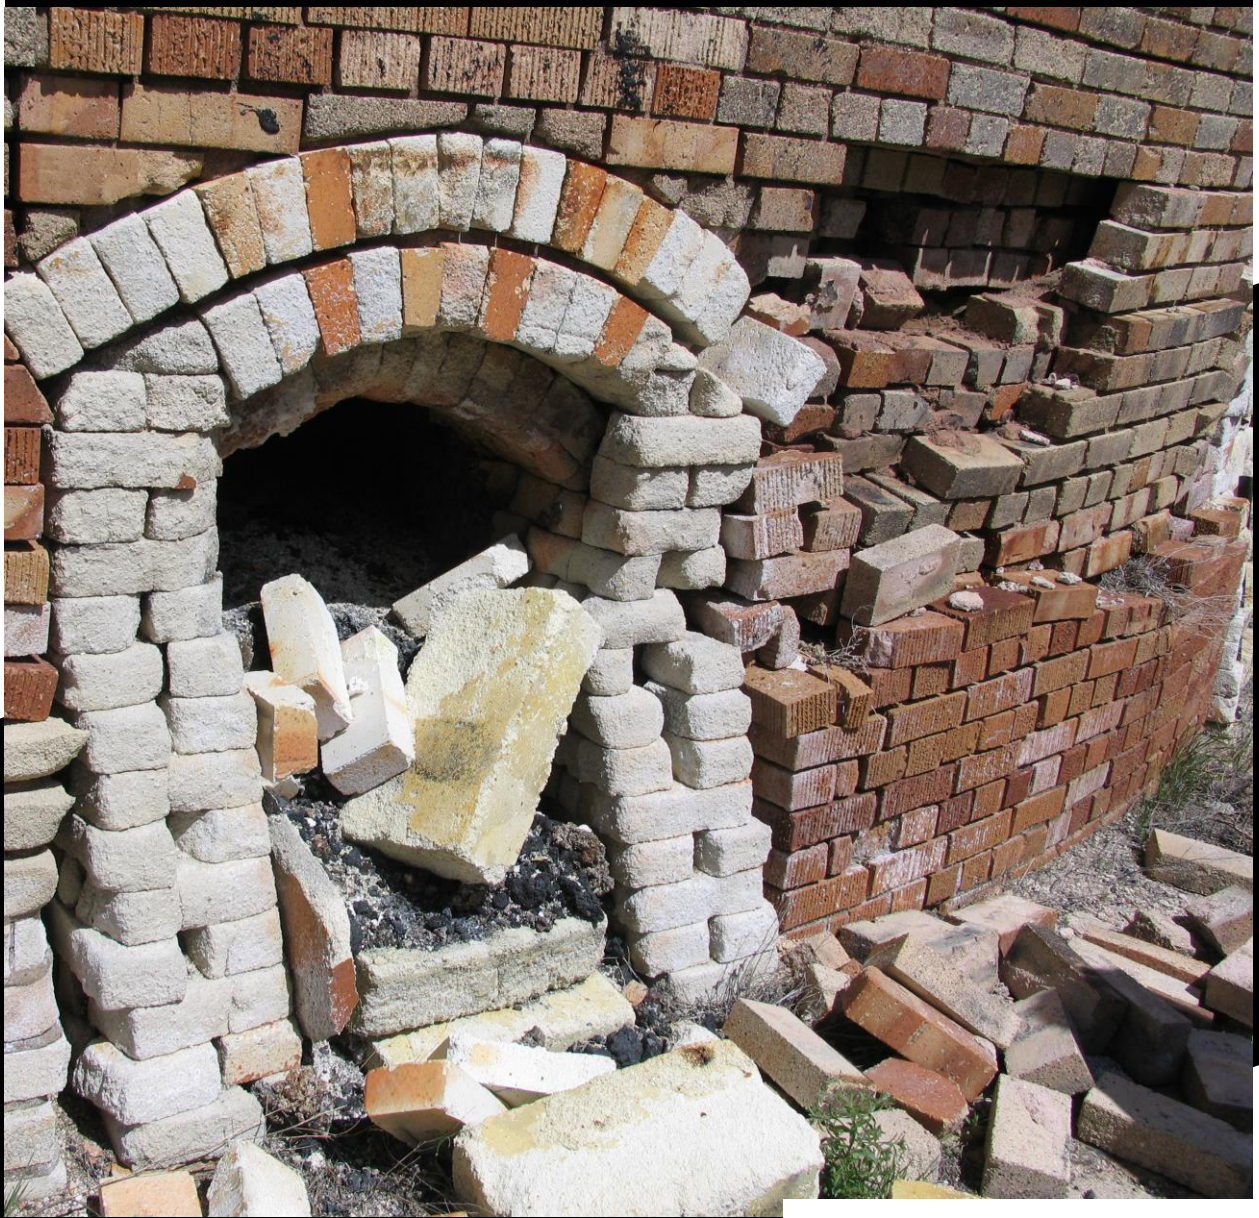
Cover Photo - DESTABILIZED EXTERNAL WALL, CLAYBANK BRICK PLANT/ M.G. Miller

The destabilization of older walls due to the deterioration of the inner core rubble - between the exterior and interior withes (walls) of masonry - can be a major concern, and the remedy is often to grout hidden voids within the loosely bound rubble.

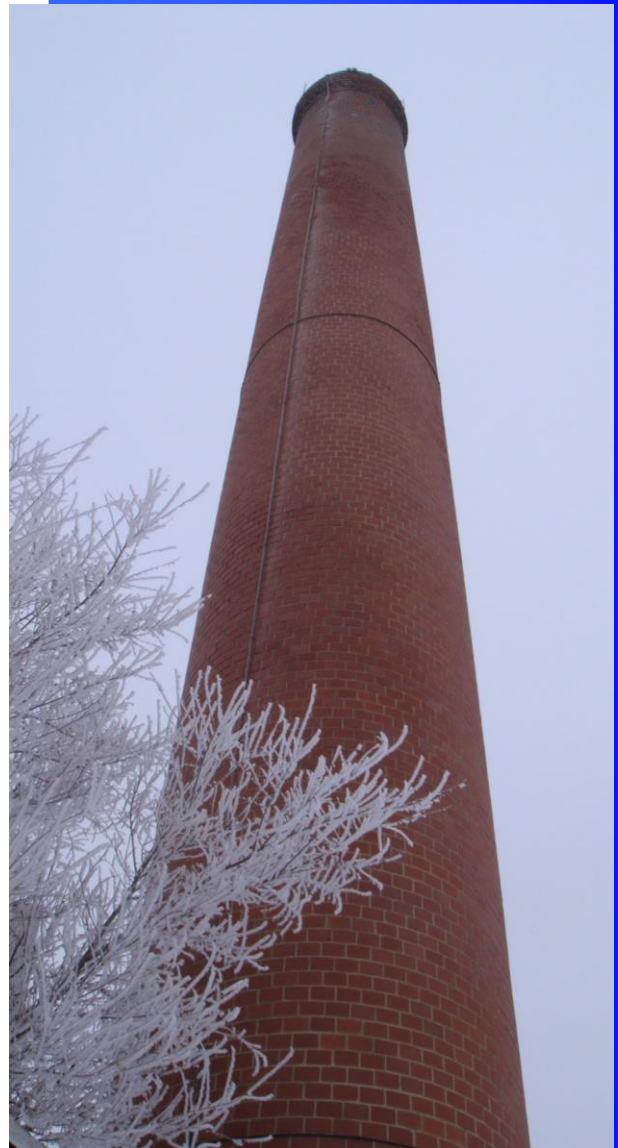
Fig. 5—The Soo Line Historical Museum, Weyburn, underwent masonry repointing in phases.

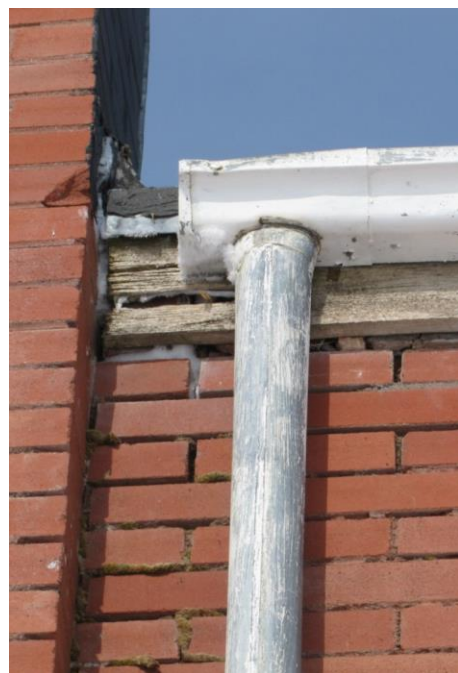
Fig. 6—Masonry damage at a common point of failure at the Khedive Recreation Centre, Khedive.

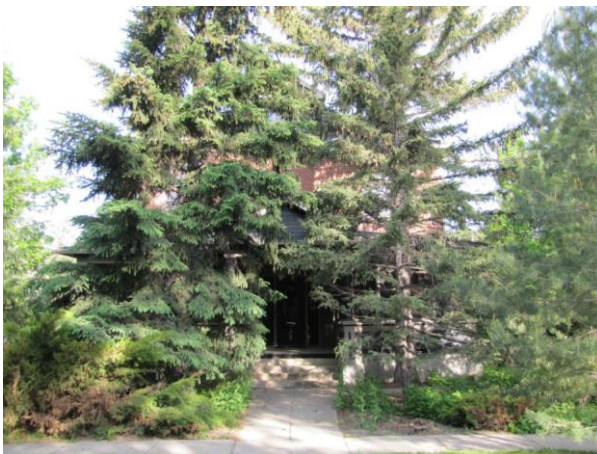
Fig. 12—Residence in Maple Creek showing trees close to the foundation.

Phosphates can also be introduced in masonry by fertilizer or plantings near the foundation.

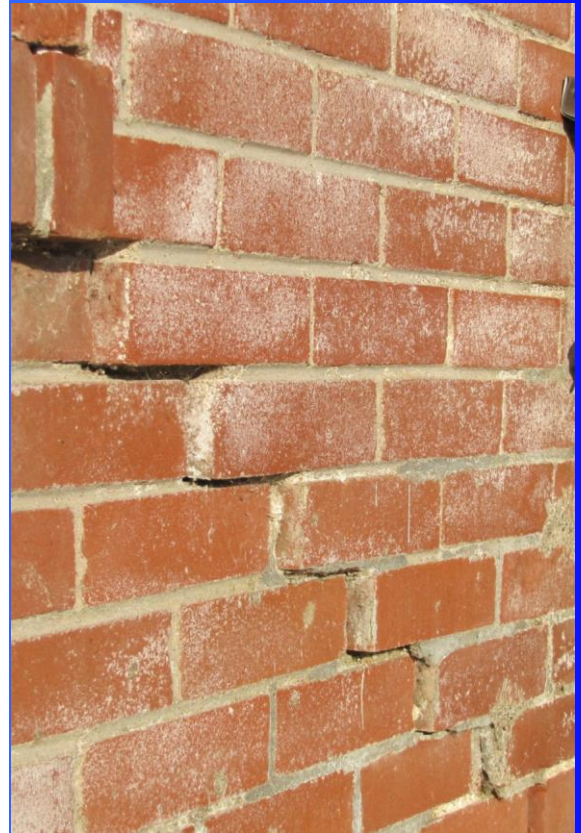
Fig. 13—A masonry wall shifts out of plane at the Veteran’s Memorial Hall in Earl Grey.

Slight bulging or shifting out of plane in a portion of a masonry wall often indicates that the brick or stone masonry surface veneer is separating from the rest of the wall. This may be because water is entering at a crack or joint, dissolving mortar, rusting ties, or freezing and moving brick or stone outward.

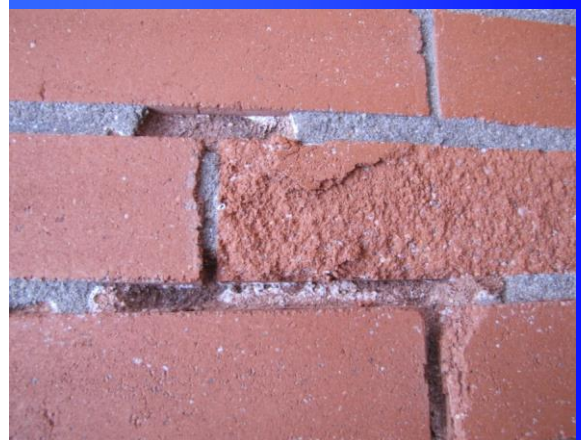
Fig. 14—Spalled masonry unit at Khedive Recreation Centre, Khedive.

Spalling of brick often reflects elevated levels of moisture in masonry but may also be caused by defects in the original masonry unit. An under-fired brick may spall while an adjacent brick remains sound under the same moisture conditions. In a typical Saskatchewan winter, high moisture content in masonry may lead to frost *spalling* or *jacking*, the fracturing of brick due to the freezing of water in porous masonry.

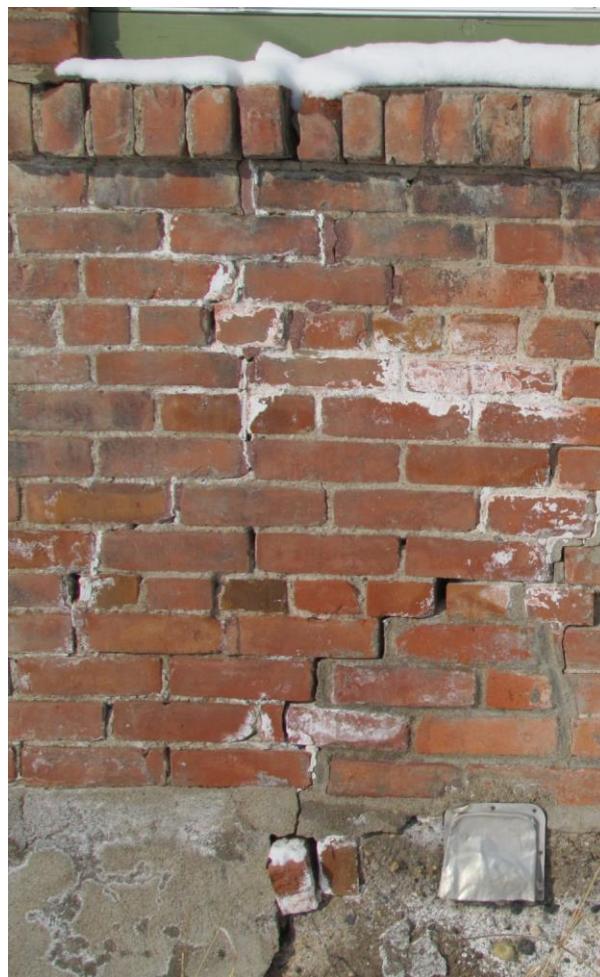
Fig. 15— Soiling and efflorescence at The Stoop, Rouleau

Efflorescence on the inside of the foundation walls indicates that exterior foundation surfaces are inadequately protected against water infiltration. Whatever the salt, efflorescence is a certain sign that moisture is entering a wall.

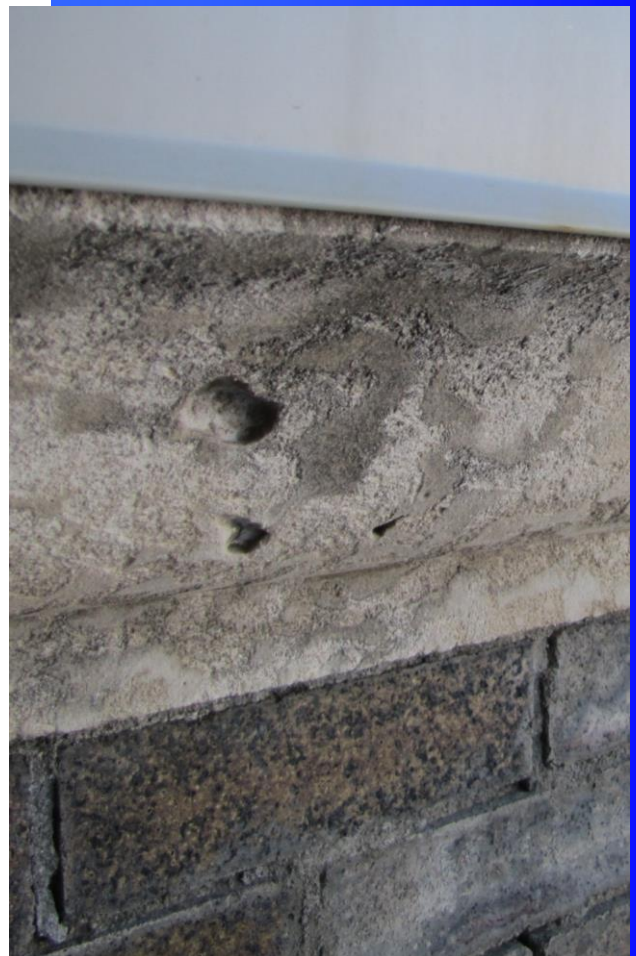
The type of soiling that may be found at cornices such as that depicted below, need not be removed—this is called patina . Except for those situations where patina is causing moisture damage or reducing the structural integrity of historic fabric, it should be retained.

Fig. 16—Encrusted patina on the stone cornice at the former Land Titles Office in Moose Jaw.

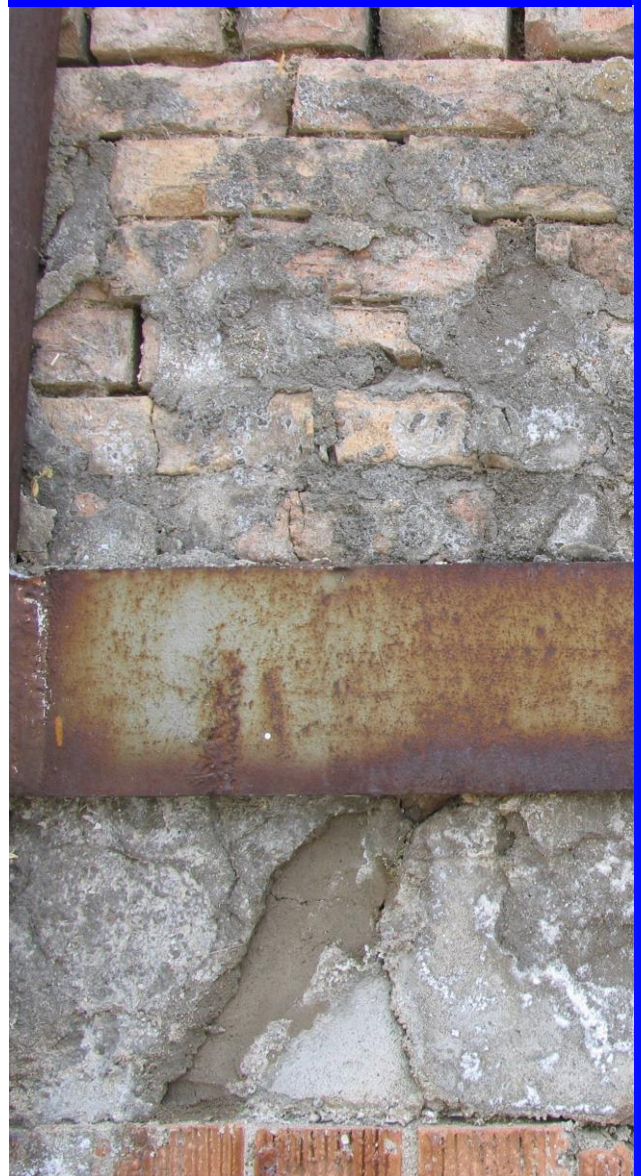
Fig. 18—Previous masonry repairs at a kiln at the Claybank Brickplant, National Historic Site.

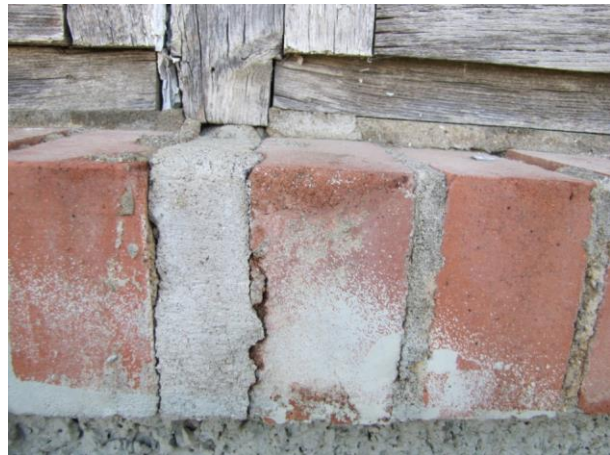
Fig. 19—Mortar joints at the Veteran's Memorial Hall in Earl Grey.

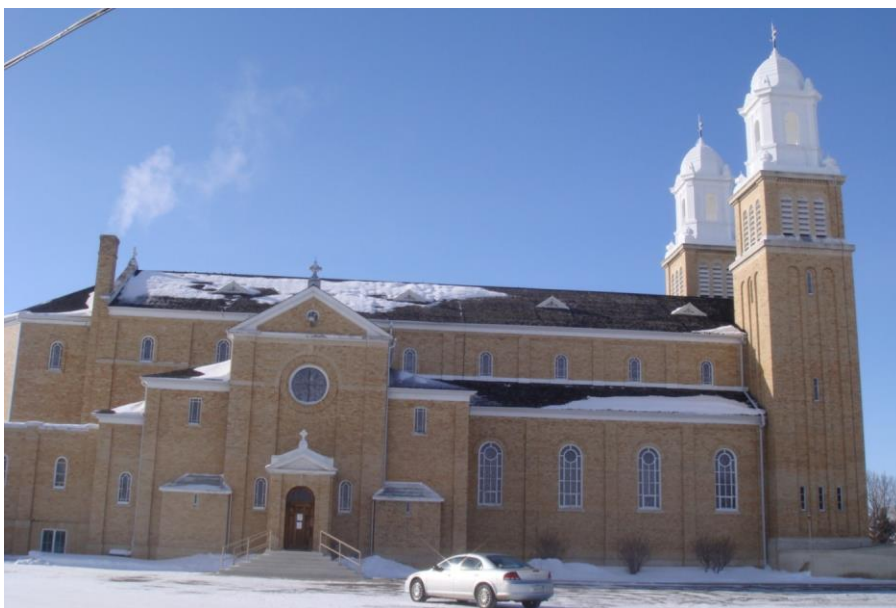
Fig. 21—The analysis of the historic mortar mix at the Co-Cathedral in Gravelbourg led to the selection of Type K mortar for its repointing.

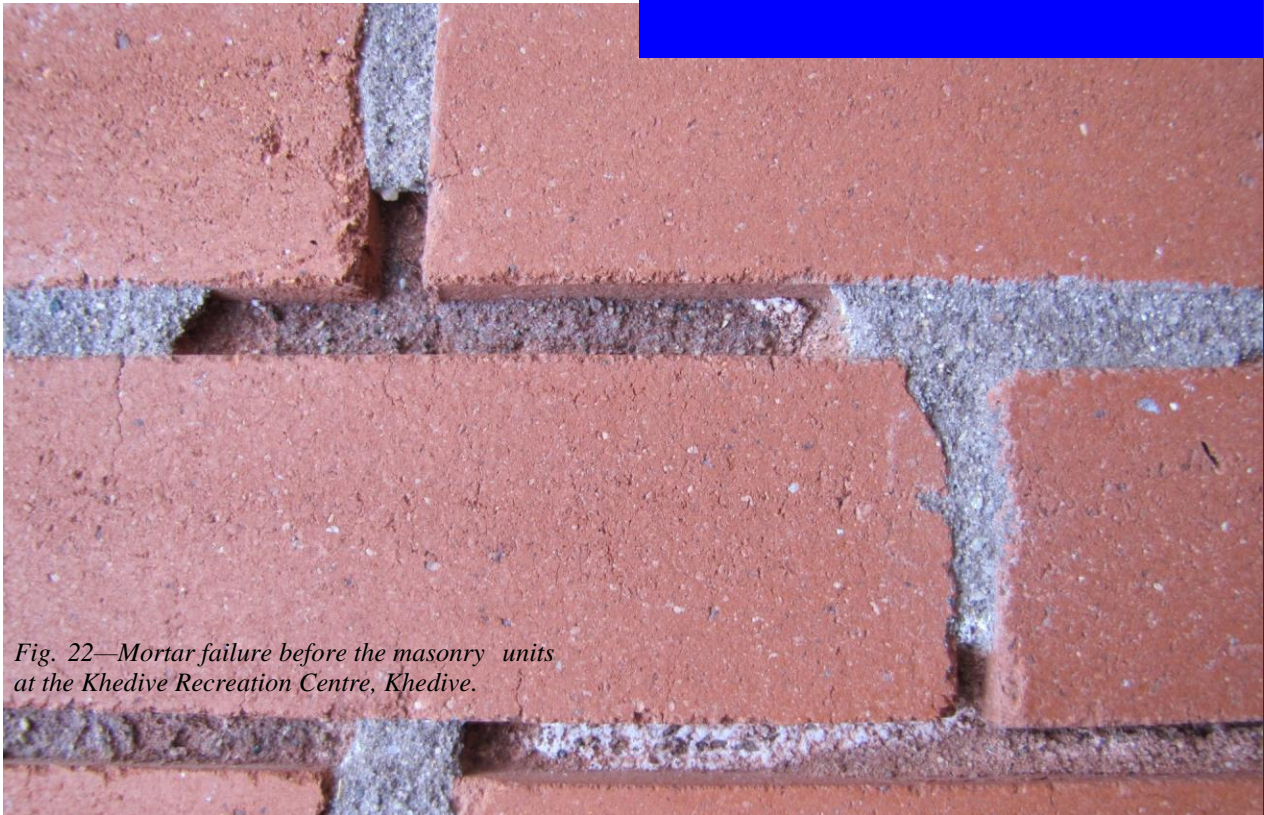
Fig. 22—Mortar failure before the masonry units at the Khedive Recreation Centre, Khedive.

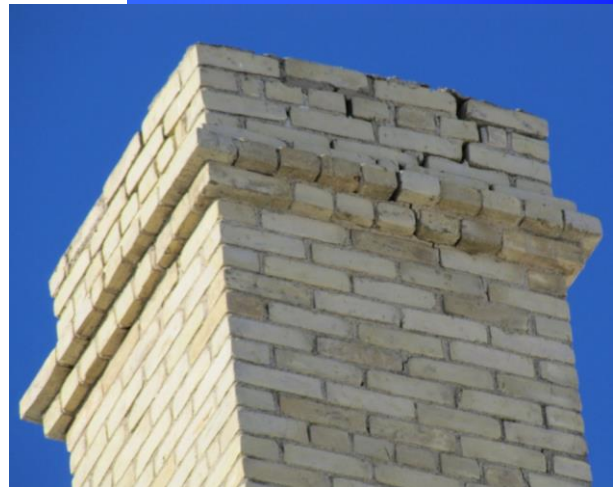
Fig. 28—Loose masonry at the Assumption Catholic Church in Holdfast.

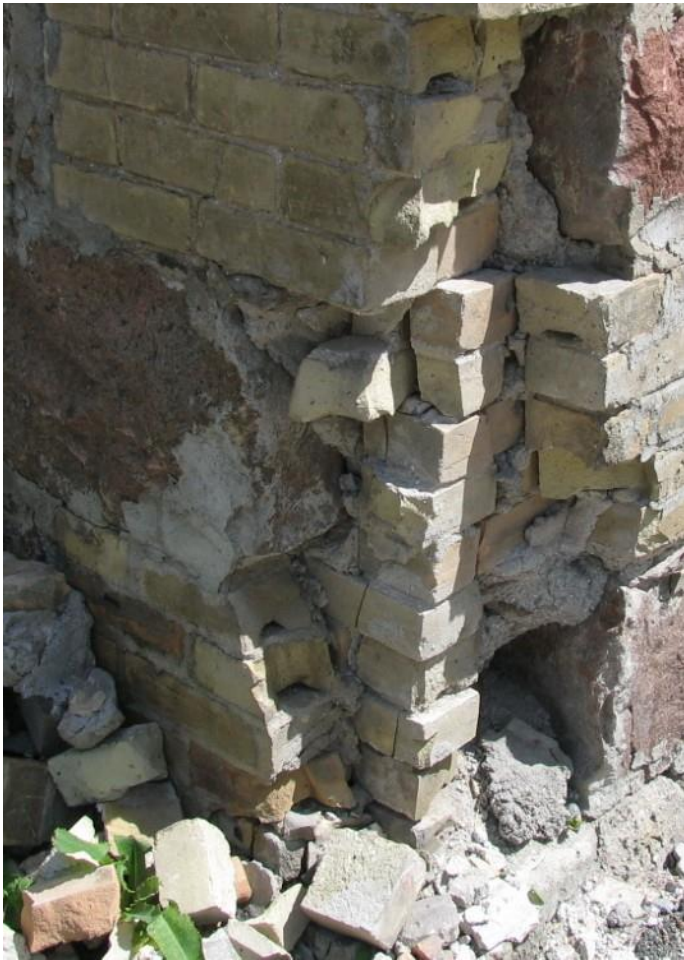
Fig. 29— Dislodged masonry at the 1886 McNaughton Stores in Moosomin.
